Diocese of Durham  
**All Saints Church, Wheatley Hill**

**Quinquennial Report**  
On the architect's inspection of

**14<sup>th</sup> July 2023**

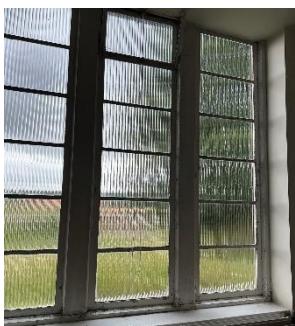
Figure 35 – south glass

#### 16. GLASS – all clear single glazed in good condition.

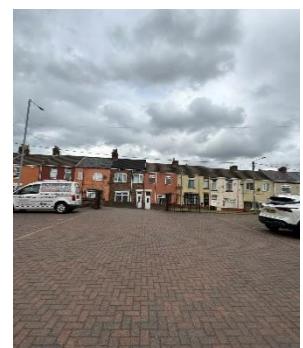
Figure 39 – parking area

26.2 North Boundary: Good block paved car park and well maintained grassed areas. Low brick wall to roadside. Painted metal gates to entrance await possible future railings when funds allow. Low kerbs could be trip hazards so these would be better to be highlighted or surrounded by planters to eliminate hazard.
