QUINQUENNIAL INSPECTION REPORT - APRIL 2023

HOLY TRINITY CHURCH

FRONT STREET, WINGATE, CO. DURHAM, TS28 5AN

Report prepared by

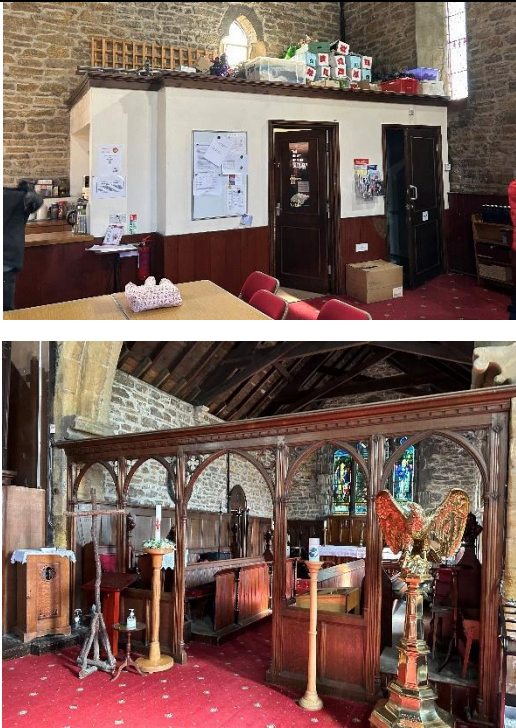
Partitions, Screens and Panelling

<p>Description</p> <ul style="list-style-type: none"> • There is varnished half height timber panelling throughout the Nave and the Chancel. • There is a decorative oak screen set within the arch between the Chancel and the Nave. • There are insulated timber stud partitions, forming the newer WC and flower room block within the Nave. WC is tiled and flower room is painted plasterboard finish. 	
	<p>Condition</p> <ul style="list-style-type: none"> • Timber panelling appears in good condition. • The timber screen is in good condition. • Stud partitions to WC/ flower room block and the walls finishes are sound. 	
	<p>Repair Needs</p> <p>None</p>

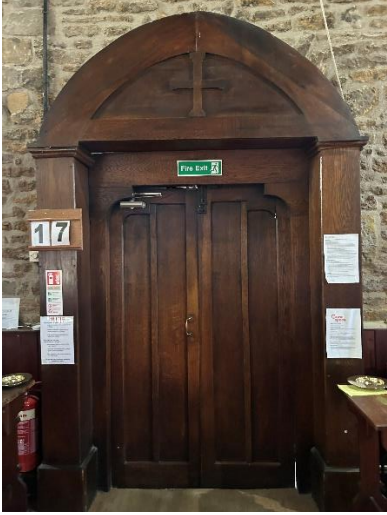
Interior Doors

<p>Condition</p> <p>All doors appear sound.</p>	
	<p>Repair Needs</p> <p>None</p>

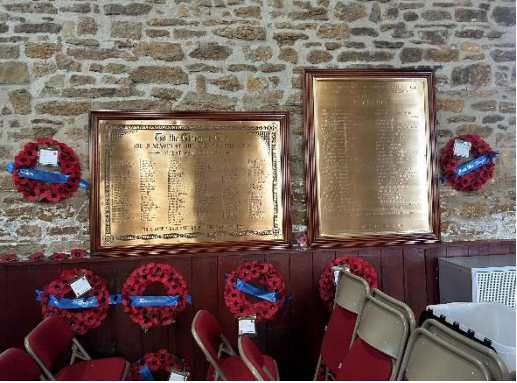
11.6 MONUMENTS AND TOMBS

<p>Description</p> <ul style="list-style-type: none"> There are 3no. marble wall memorial plaques 2no. Brass 1st & 2nd world war memorials. There are also various other banners and signs hanging throughout the church. <p>Condition</p> <ul style="list-style-type: none"> All in good condition. <p>Repair Needs</p> <ul style="list-style-type: none"> None 	
---	--	--

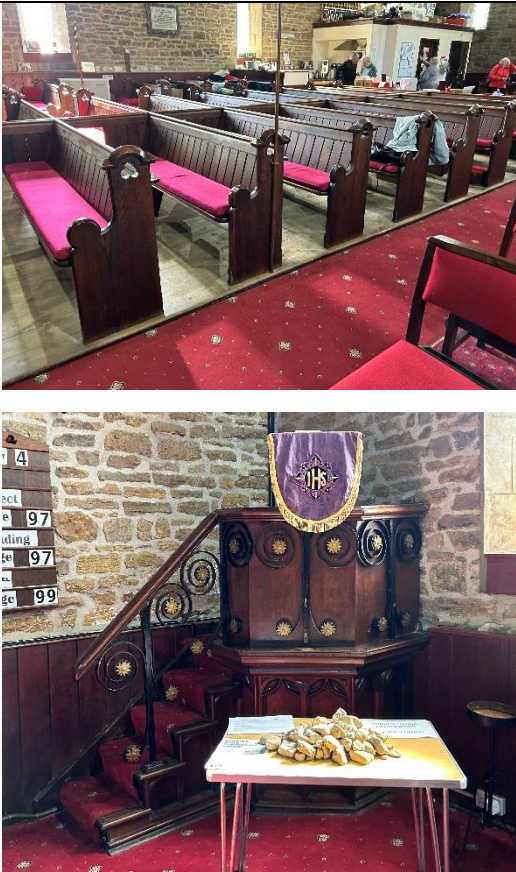
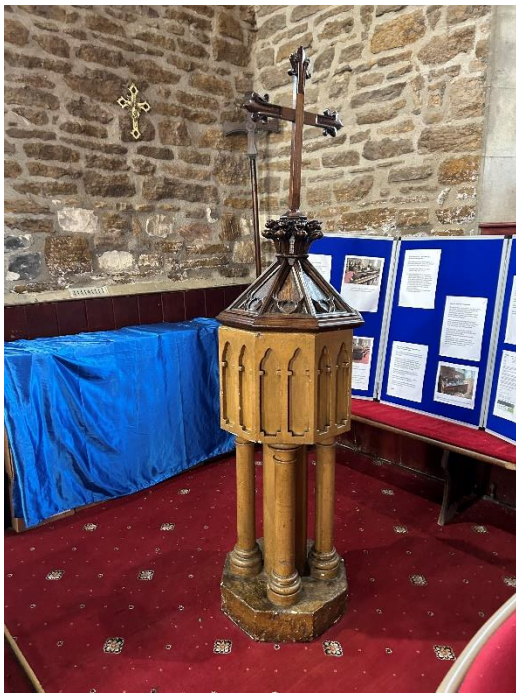
11.7 FIXTURES, FITTINGS AND FURNITURE

<p>Condition</p> <ul style="list-style-type: none"> • Pews and choir stalls all appear secure and in sound condition. • The pulpit is sound and stable. • The font appears in good condition. • The alter appears sound. <p>The brass eagle is in good condition.</p>	
	<p>Repair Needs</p> <ul style="list-style-type: none"> • None
