QUINQUENNIAL INSPECTION REPORT - APRIL 2018

# HOLY TRINITY CHURCH

FRONT STREET, WINGATE, CO. DURHAM, TS28 5AN

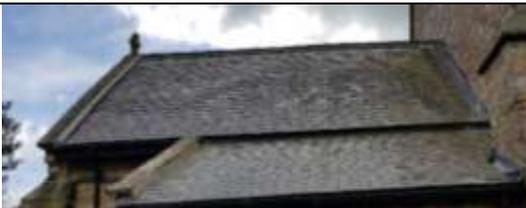
**Northern Pitch of Chancel Roof**

<p><b>Description</b></p> <ul style="list-style-type: none"> <li>• Natural Slates</li> <li>• Profiled terracotta ridge tiles</li> <li>• Modern non-lead flashings to water table on east.</li> <li>• Modern non-lead flashing chased into stone on Nave wall to the west.</li> <li>• A stone cross is located on the Eastern side of the Chancel roof on the water table.</li> </ul>	
	<p><b>Condition</b></p> <ul style="list-style-type: none"> <li>• The roof appears sound.</li> <li>• There are a few slipped slates.</li> </ul>	
	<p><b>Repair Needs</b></p> <ul style="list-style-type: none"> <li>• Monitor slates and refix any which continue to slip, or are blown off.</li> </ul>	M

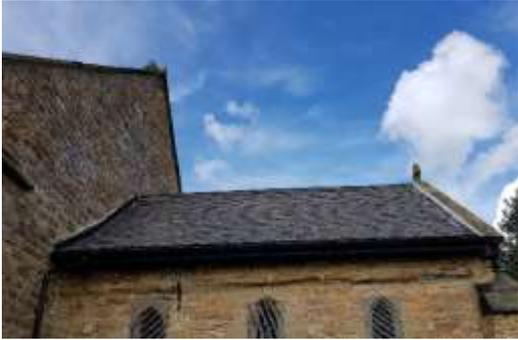
**Southern Pitch of Chancel Roof**

<p><b>Description</b></p> <ul style="list-style-type: none"> <li>• Natural Slates</li> <li>• Profiled terracotta ridge tiles</li> <li>• Water table to east gable</li> <li>• Modern non-lead flashing to water table at East and chased into Nave wall on West side.</li> </ul>	
	<p><b>Condition</b></p> <ul style="list-style-type: none"> <li>• There are a few slipped / chipped slates towards the bottom of the roof.</li> <li>• Ridge tiles appear to be well bedded and pointed.</li> <li>• The non-lead flashing appears sound.</li> </ul>	
	<p><b>Repair Needs</b></p> <ul style="list-style-type: none"> <li>• Monitor slates and refix any which continue to slip, or are blown off.</li> </ul>	M

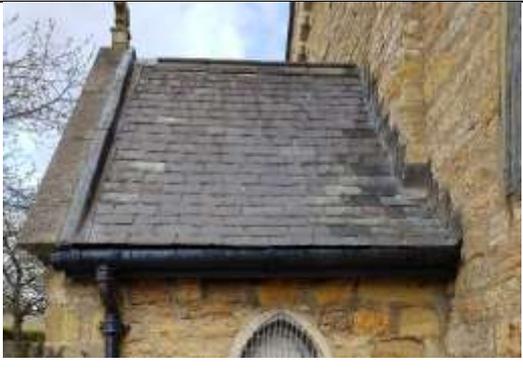
**Southern Pitch of Porch Roof**

<p><b>Description</b></p> <ul style="list-style-type: none"> <li>• Natural slates</li> <li>• Profiled terracotta ridge tiles</li> <li>• Water table to west gable.</li> <li>• Stone cross on water table.</li> <li>• Lead flashing to water table and cut into Nave Wall.</li> </ul>	
	<p><b>Condition</b></p> <ul style="list-style-type: none"> <li>• The roof appears generally sound, there are a few chipped / slipped slates.</li> <li>• Ridge tiles appear sound and well bedded.</li> </ul>	
	<p><b>Repair Needs</b></p> <ul style="list-style-type: none"> <li>• Monitor slates and refix any which continue to slip, or are blown off.</li> </ul>	<p>M</p>

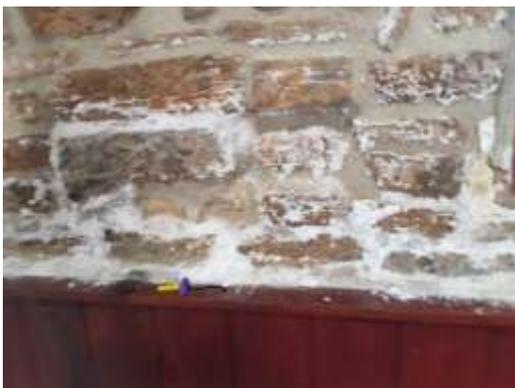
Chancel/nave arch

- The internal stone walls generally appear to be in good condition.
- The stone surround to the inner door in the porch is damp and decayed in places.
- There is efflorescence present on the lower parts of the north wall in the Nave, particularly thick above the timber panelling.
- The stone arch between the chancel and the nave appears to be in reasonable condition at high level, with efflorescence and some delamination of the stone present at low level.
- There is efflorescence present on the stone at high level above the Chancel / Nave arch.
- There is efflorescence present to the east wall of the Chancel.

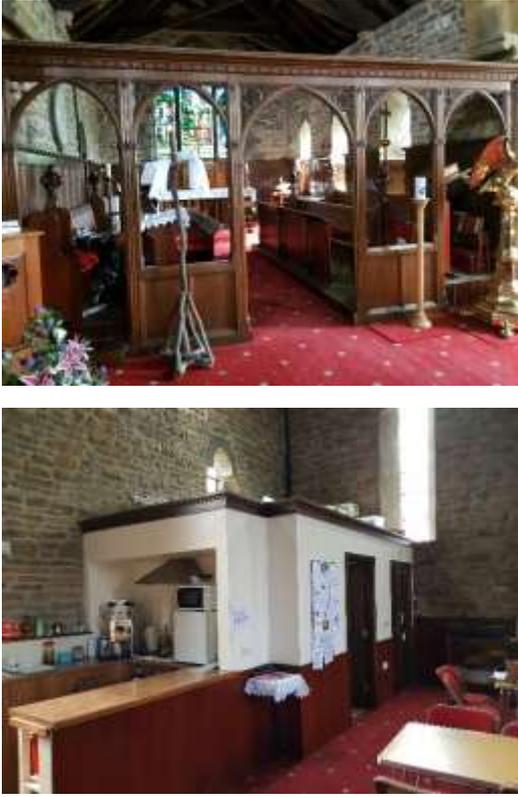
**Partitions, Screens and Panelling**

<p><b>Description</b></p> <ul style="list-style-type: none"> <li>• There is varnished half height timber panelling throughout the Nave and the Chancel.</li> <li>• There is a decorative oak screen set within the arch between the Chancel and the Nave.</li> <li>• There are insulated timber stud partitions, forming the newer WC and flower room block within the Nave. WC is tiled and flower room is painted plasterboard finish.</li> </ul>	
	<p><b>Condition</b></p> <ul style="list-style-type: none"> <li>• Timber panelling appears in good condition.</li> <li>• The timber screen is in good condition.</li> <li>• Stud partitions to WC/ flower room block and the walls finishes are sound.</li> </ul>	
	<p><b>Repair Needs</b></p> <ul style="list-style-type: none"> <li>• None</li> </ul>

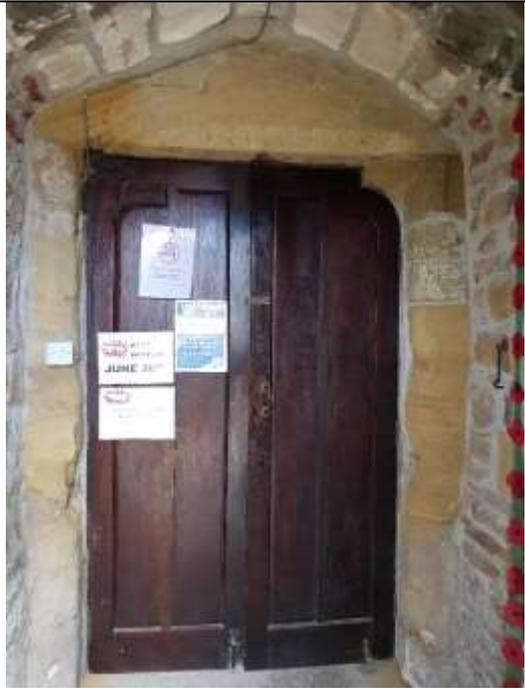
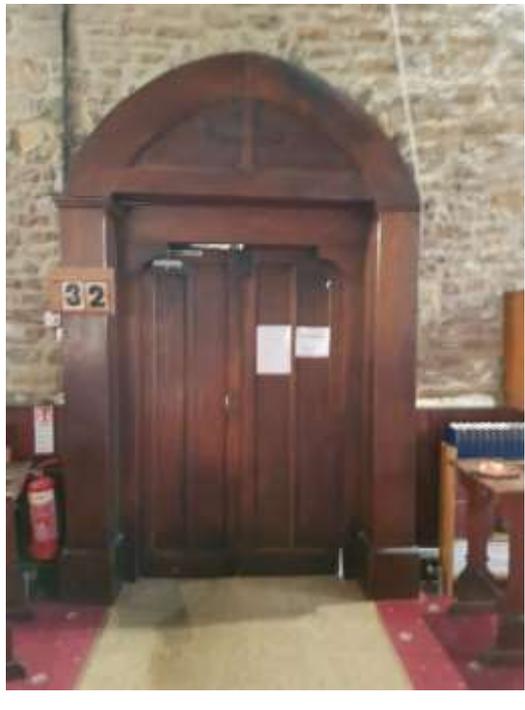
Interior Doors

<p><b>Condition</b></p> <ul style="list-style-type: none"> <li>• All doors appear to be sound.</li> </ul>	
	<p><b>Repair Needs</b></p> <ul style="list-style-type: none"> <li>• None</li> </ul>

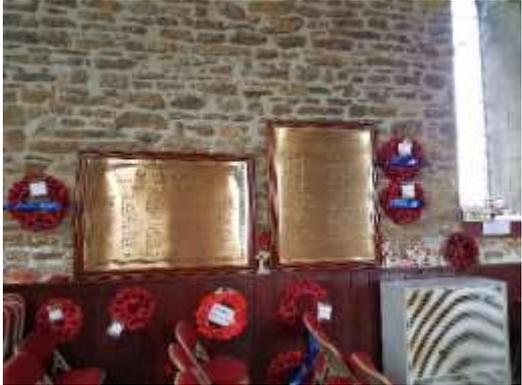
11.6 MONUMENTS AND TOMBS

<p><b>Description</b></p> <ul style="list-style-type: none"> <li>• There are 3no. marble wall memorial plaques</li> <li>• 2no. Brass 1<sup>st</sup> &amp; 2<sup>nd</sup> world war memorials.</li> <li>• There are also various other banners and signs hanging throughout the church.</li> </ul> <p><b>Condition</b></p> <ul style="list-style-type: none"> <li>• All in good condition.</li> </ul> <p><b>Repair Needs</b></p> <ul style="list-style-type: none"> <li>• None</li> </ul>	
---	--	--

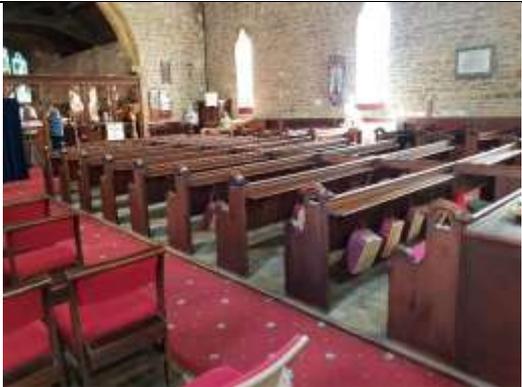
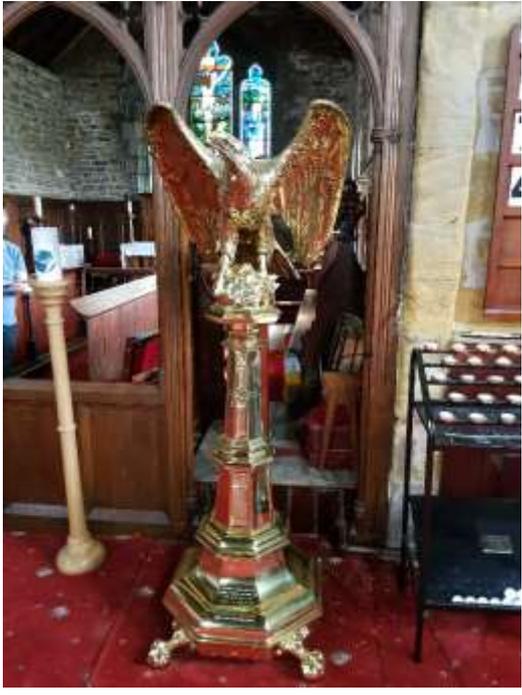
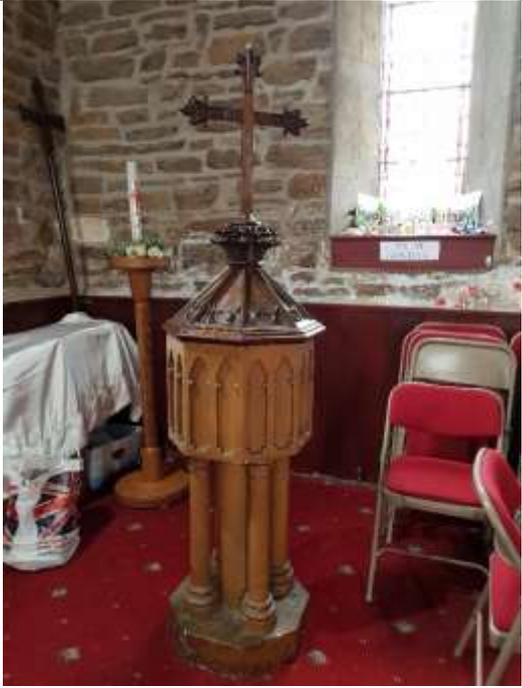
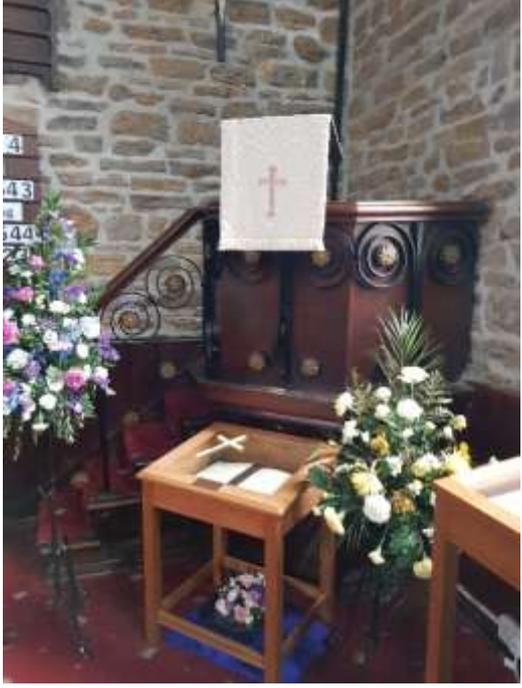
11.7 FIXTURES, FITTINGS AND FURNITURE

<p><b>Condition</b></p> <ul style="list-style-type: none"> <li>• Pews and choir stalls all appear secure and in sound condition.</li> <li>• The pulpit is sound and stable.</li> <li>• The font appears in good condition.</li> <li>• The alter appears sound.</li> <li>• The brass eagle is in good condition.</li> </ul>

<p><b>Repair Needs</b></p> <ul style="list-style-type: none"> <li>• None.</li> </ul>

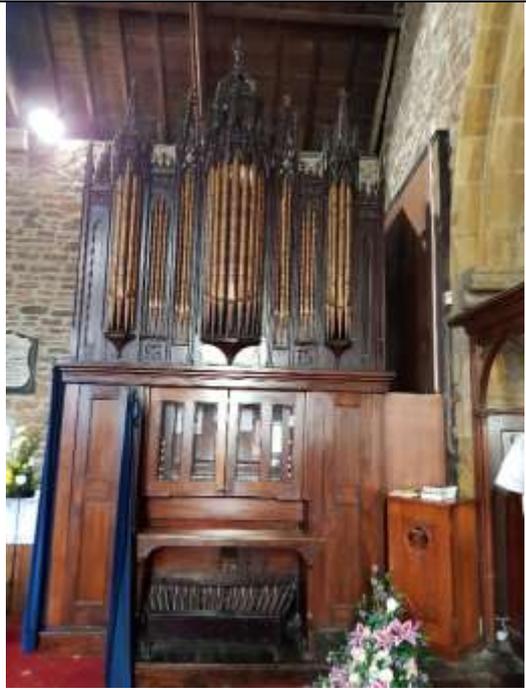
11.8 ORGAN

<p><b>Description</b></p> <p>The organ, is a 2 manual 15 stop pipe instrument built by Nelson &amp; Co. Durham, and is located in the north east corner of the Nave.</p> <p><b>Condition</b></p> <ul style="list-style-type: none"> <li>The logbook indicates the Organ was last serviced in July 2017. Some emergency repair works were carried out in February 2018 and it was tuned in March 2018.</li> </ul> <p><b>Repair Needs</b></p> <ul style="list-style-type: none"> <li>Continue regular tuning and servicing by a specialist.</li> </ul>	<p>M</p>
---	--	----------
