**QUINQUENNIAL INSPECTION REPORT
OF
WINSTON, ST. ANDREW**

**DIOCESE OF DURHAM
ARCHDEACONRY OF AUCKLAND
DEANERY OF BARNARD CASTLE**

QUINQUENNIAL INSPECTION AND REPORT

August 2023 Rev A

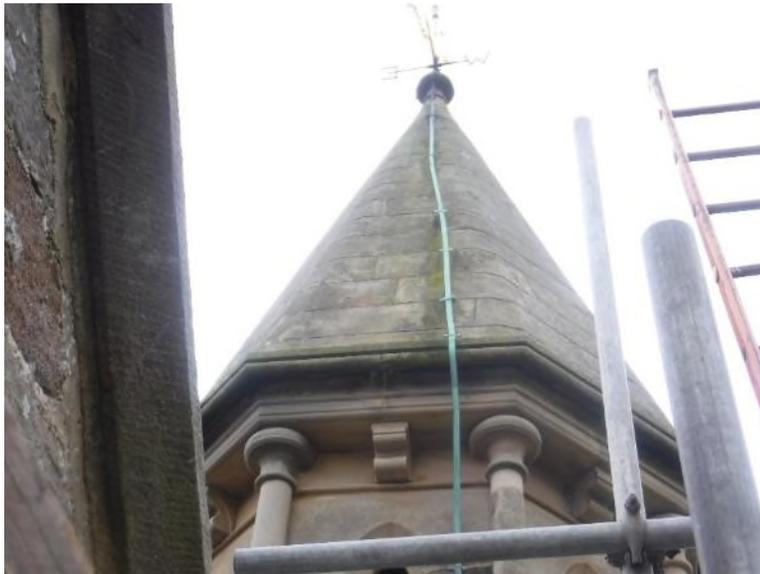
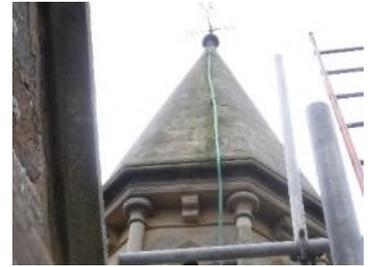
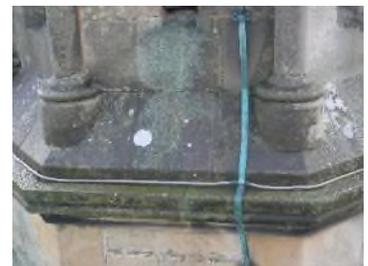
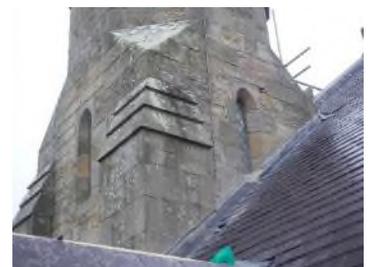
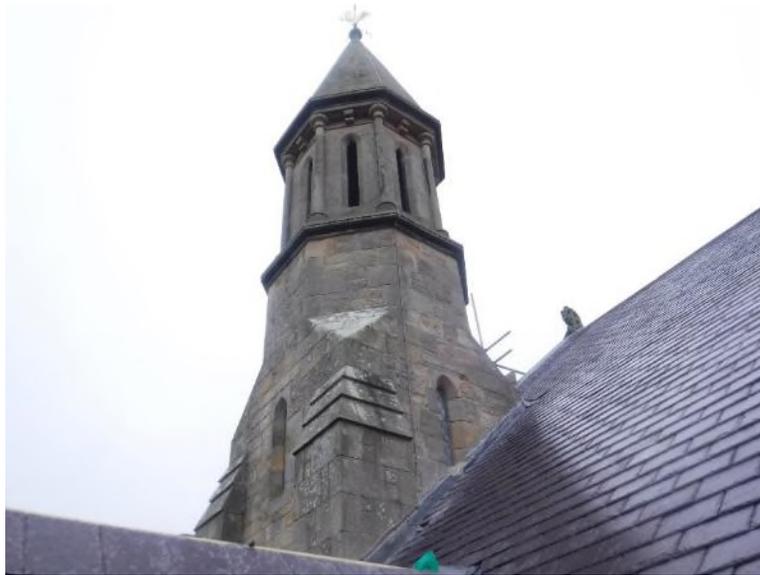
Octagonal ashlar stonework topped with a button finial and cockerel and weathervane. Slight open joints at the sloping corners of the stones. Below that, octagonal belfry with circular columns at the corners and it looks like there may have been replacement shaft elements in the past, but it all looks sound now, the walling of the belfry is rather big units and there are few joints on it that looks ok and within the openings are slate louvres that look ok. At the base of the columns is a sloping stringcourse running round and I suspect open joints on the sky facing surface.

Recommendation: tidy up base of tower. Have the top inspected by steeplejack (perhaps same time as lightning conductor inspection?)

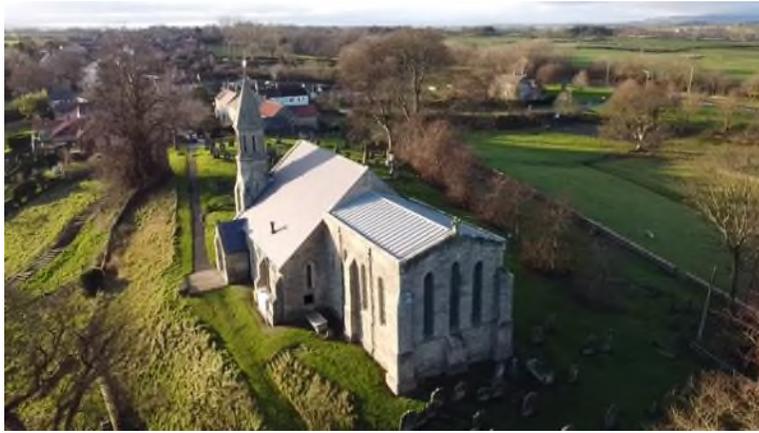
Recovered in 2018 with terne coated stainless steel on new sarking and insulation to lead parapet gutters, not able to be seen from the ground but the north side was seen on the 2020 works and appeared ok.

Recommendation: none

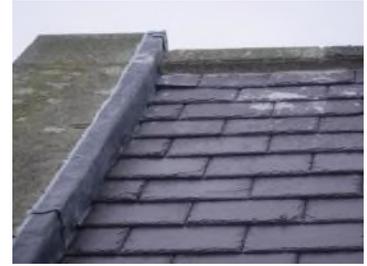
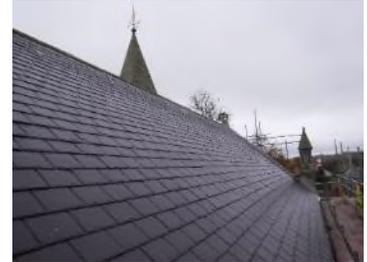
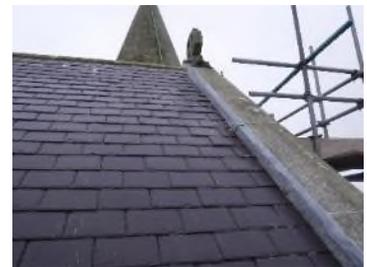
Re-slatted in 2020 in new Welsh slate on new roofing felt, no insulation was able to be added as the plaster ceiling is fixed straight to the underside of the slating battens and there wasn't an economic way of achieving this. Re-bedded ridges all look ok.

There is a possible problem in the nave south side junction to the tower buttress. It was remade as it was originally shaped but its performance suggests that it should be bigger (or its clogged up). Ranson Roofing has been asked to revisit to check over the gutter.

Recommendation: Ranson to check gutter condition

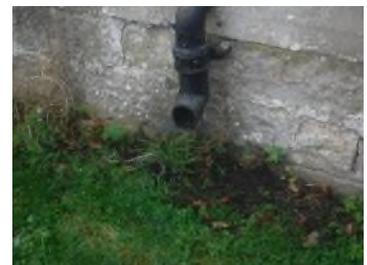
E Stainless steel lined parapet gutter to the chancel. The remainder of the church is cast-iron half round gutters which were replaced in 2020 with the existing downpipes retained which all look ok, they discharge to gullies which in turn lead to soakaways it is reported. But I have my doubts that there is an efficient system as walls- particularly north are wet.

Recommendation: check for a drainage system.

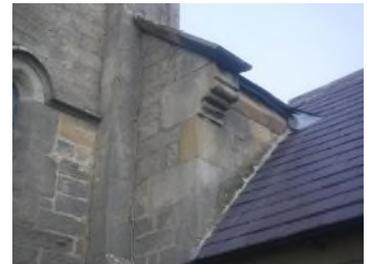
The oil tank restricts access to the walling and the paintwork is rusting now. Metal grills below the floor are rusting wide open bars and so something could get in there.

West end – Watertable kneeler looks slightly loose but doesn't look like a problem though otherwise ok.

Recommendation: repair air grates

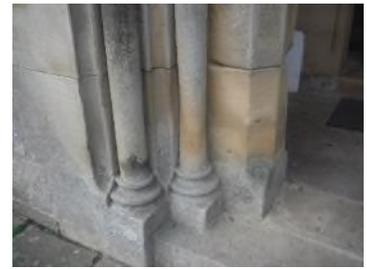
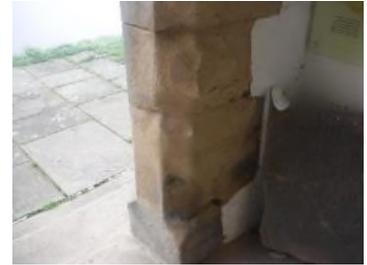
South side – Rebated watertable looks ok, some slight cracking to the open joints on the west side where the buttress is tilted slightly.

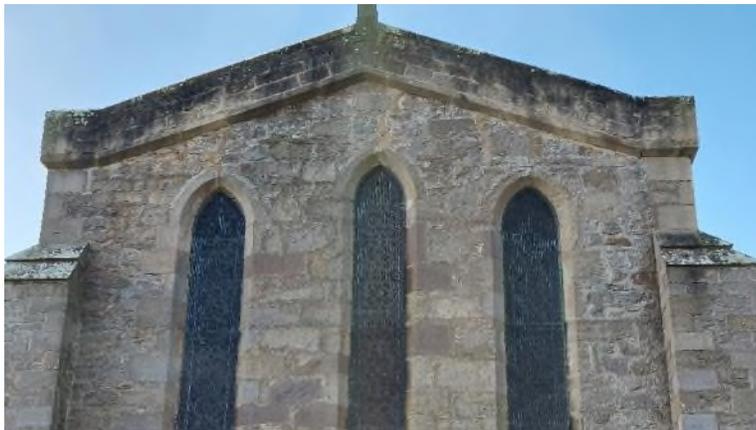
North side – Diamond pane lancets in clear glass look ok, though there is quite a lot of condensation evident.

East side – Three single light windows with grisaille glass, the ashlar surrounds look ok though there is some open joints to the lancet tops on the northern side. Windows covered by copper mesh, central window bottom mesh is looking to be coming away.

South side – Three tall windows as on the north, ashlar surrounds, some open joints now but nothing needing doing at the moment. Smaller Romanesque round top window slight breaking up of the roll moulding on the arch head which is a shame and this like all the others seems to have been cement pointed in.

Recommendation: refix mesh.

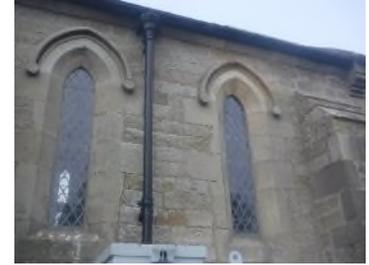
South side – Four single lancets same pattern as previously described working from left to right:

- 1) Open joint to the hoodmould and chamfered arch glass ok.
- 2) Slight movement to the east side of the arch has been repointed looks ok. Some minor shear cracking to the stonework at the cill.
- 3) Same defect as 2.
- 4) Hoodmould has been cement pointed up here, slight open joints on the chamfer jamb.

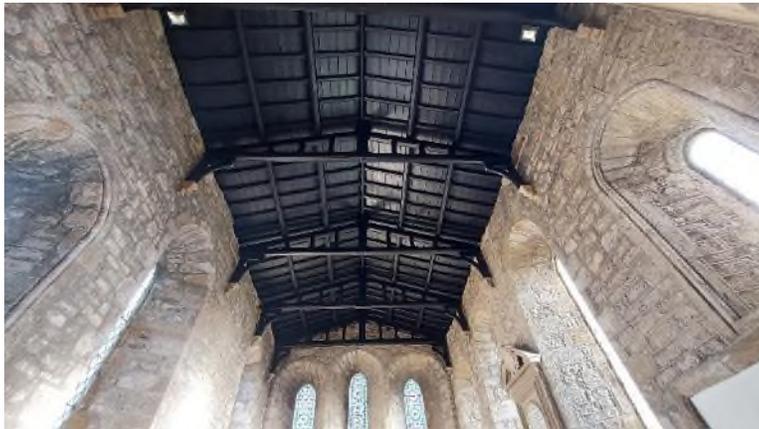
Five shallow pitch trusses with legs down to stone corbels and you can see at their junctions to the wall how much the walls have come apart in the past, they do have anchor metal work to them as part of an earlier remedial work and also the work carried out in 2018 so they are firmly fixed into place and have been redecorated.

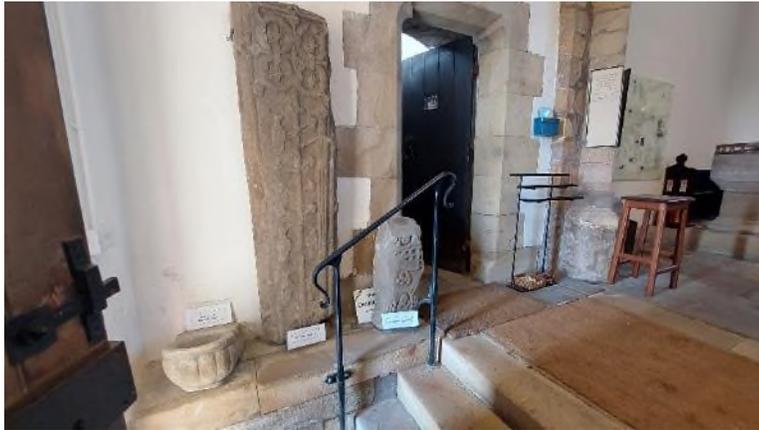
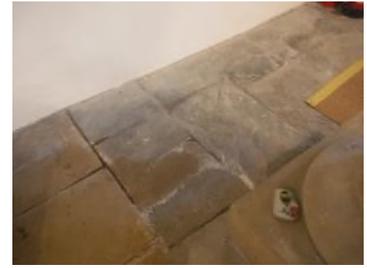
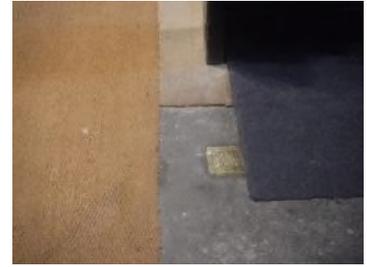
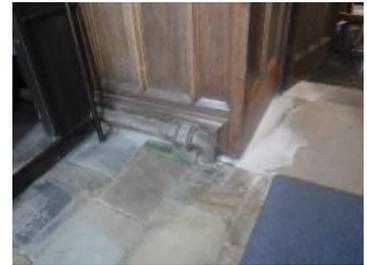
Solid floors throughout, apart from pew platforms which are timber which have ventilation grilles visible on the south side but not the north. Circulation areas in the nave and aisle are flag stones and these are generally ok, there are some open joints some slight sunk ones by the font and also by the pulpit there is some unevenness. In the chancel there is a chip on the step and damp markings to the stones particularly at the margins of the pew platforms of the choir stalls and at the entrance to the vestry, two steps up to the chancel which has a tiled floor which is humping in the middle which someone will trip over.

Recommendation: monitor

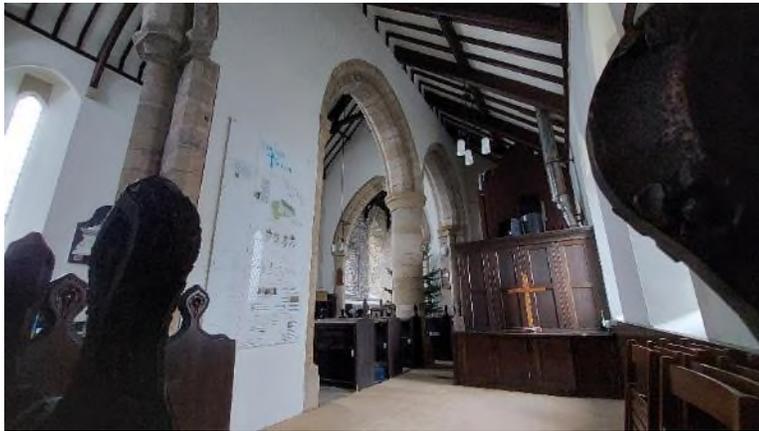
South aisle – Timber partitioning around the boiler cupboard and organ all looks ok.

Recommendation: none
