QUINQUENNIAL INSPECTION REPORT

on St Peter's Chapel
Auckland Castle

APRIL 2017

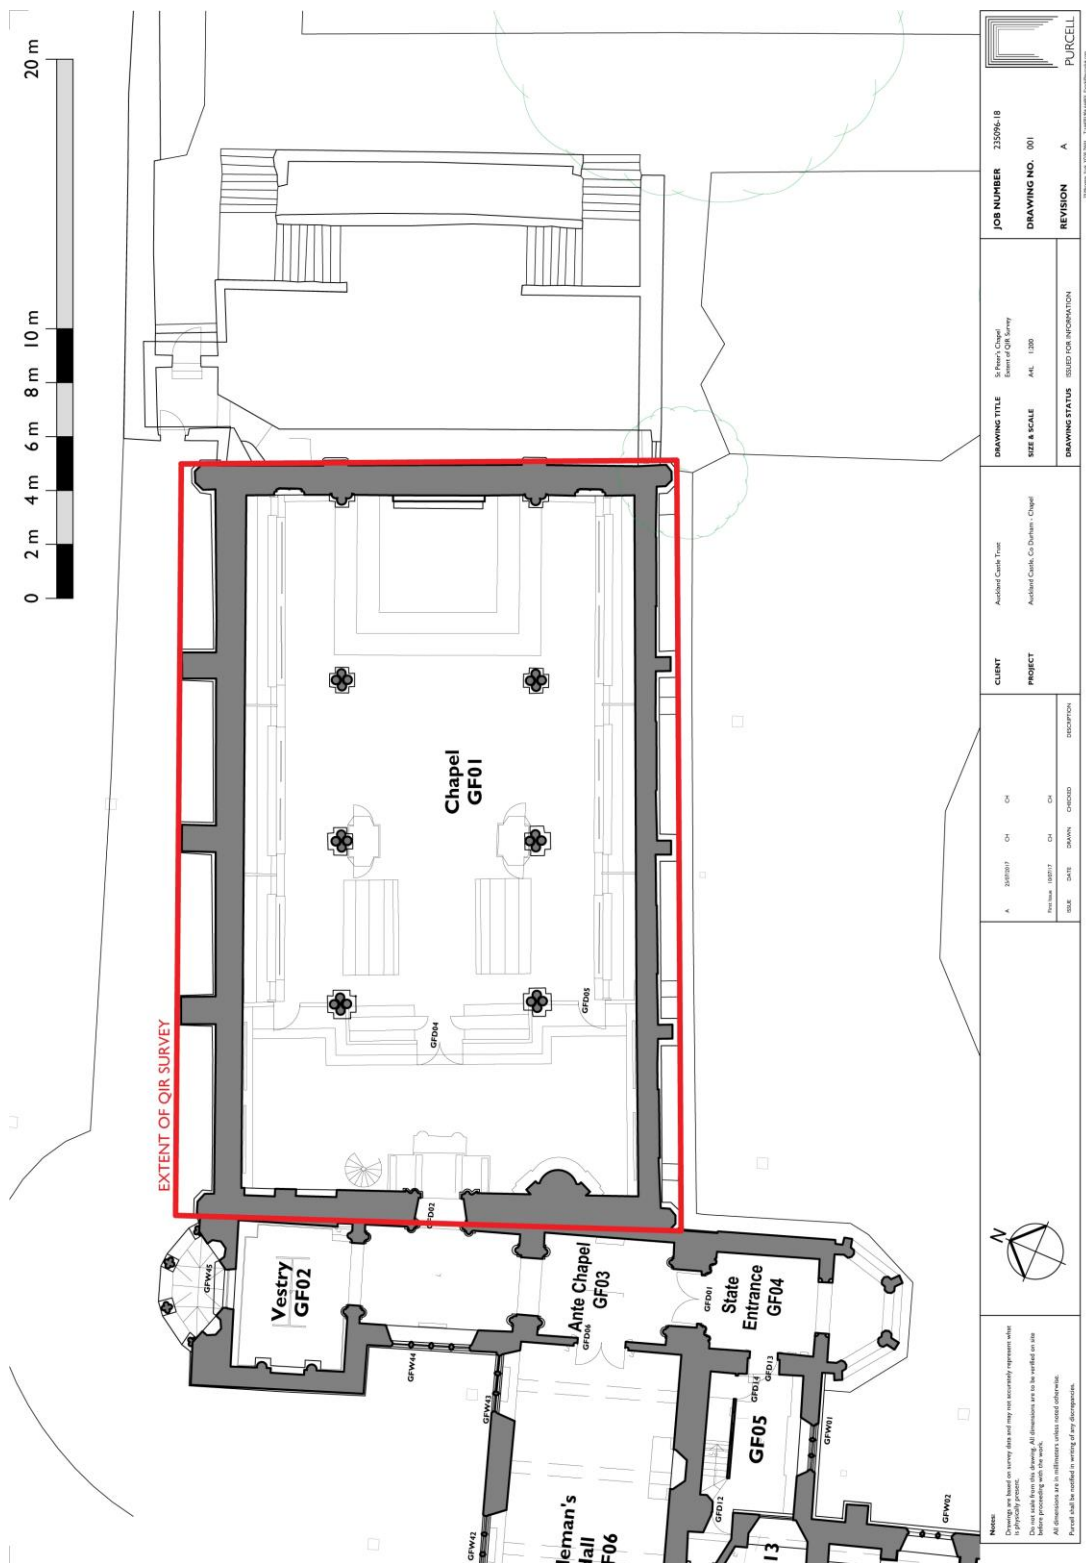
PLAN OF CHURCH

<p>Notes</p> <p>Dimensions are in millimeters unless noted otherwise.</p> <p>Form data for notations is available in the photographs.</p>		<p>Revision: A</p> <p>Date: 10/01/17</p> <p>By: [Name]</p>		<p>Project: Auckland Castle, Co. Durham - Chapel</p> <p>Client: Auckland Castle Trust</p>		<p>Job Number: 235096-18</p> <p>Drawing No.: 001</p> <p>Revision: A</p>	
<p>Drawing Title: St Peter's Chapel - Extent of QIR Survey</p> <p>Size & Scale: A4, 1:200</p> <p>Drawing Status: ISSUED FOR INFORMATION</p>		<p>Scale: 1:200</p> <p>Date: 10/01/17</p> <p>By: [Name]</p>		<p>Project: Auckland Castle, Co. Durham - Chapel</p> <p>Client: Auckland Castle Trust</p>		<p>Job Number: 235096-18</p> <p>Drawing No.: 001</p> <p>Revision: A</p>
