2023 QUINQUENNIAL INSPECTION REPORT

CHURCH OF ST. GABRIEL, BISHOPWEARMOUTH (Ref: 2321)

Diocese of Durham
Archdeaconry of Sunderland
Deanery of Wearmouth

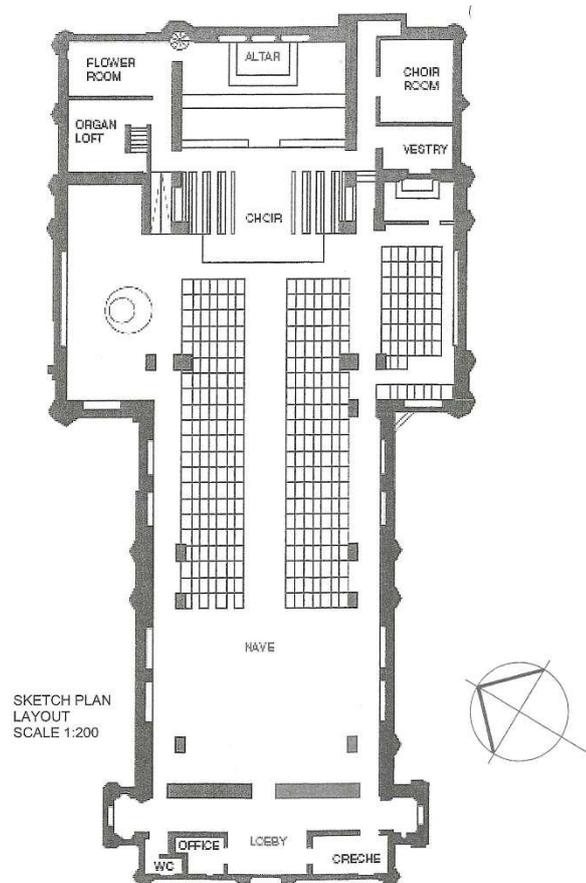
4. Plan of the church

For descriptive purposes, standard ecclesiastical orientation is used, with entrance at west and sanctuary east. Actual orientation is 35° clockwise.
