ST NICHOLAS, HEDWORTH

DIOCESE OF DURHAM

QUINQUENNIAL INSPECTION 2016

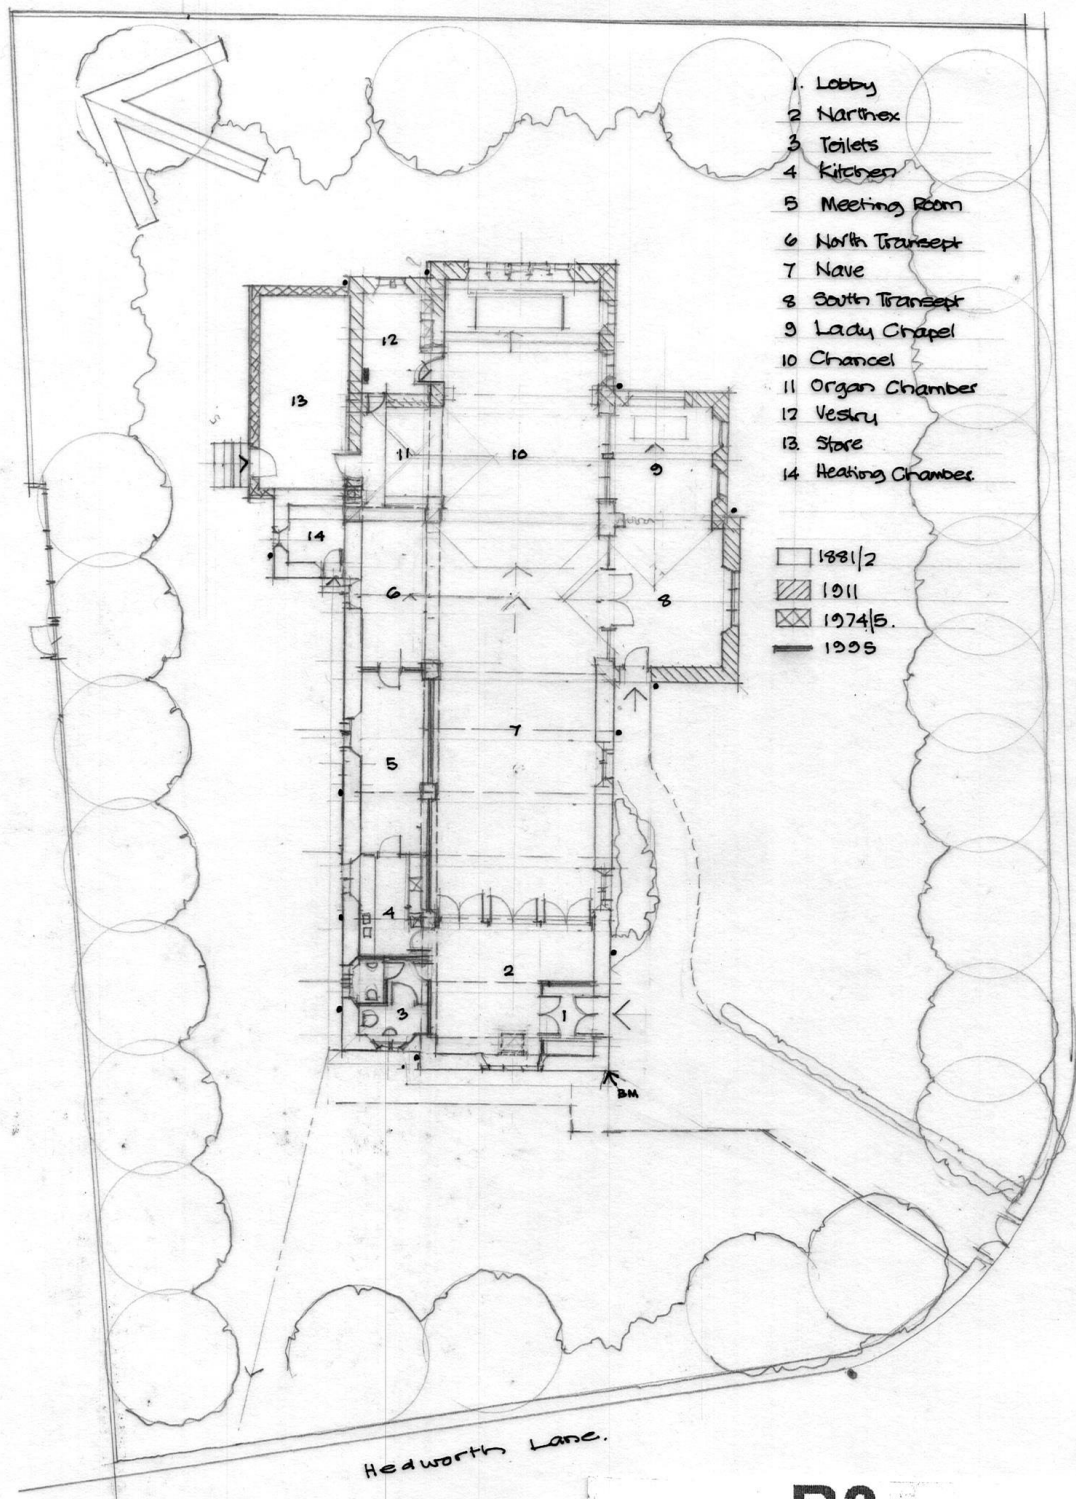
St Nicholas, Hedworth 1603
 Floor Plan SK1
 Nts Feb 2016

- 1. Lobby
- 2. Narthex
- 3. Toilets
- 4. Kitchen
- 5. Meeting Room
- 6. North Transept
- 7. Nave
- 8. South Transept
- 9. Lady Chapel
- 10. Chancel
- 11. Organ Chamber
- 12. Vestry
- 13. Store
- 14. Heating Chamber

- 1881/2
- ▨ 1911
- ▩ 1974/5
- 1995

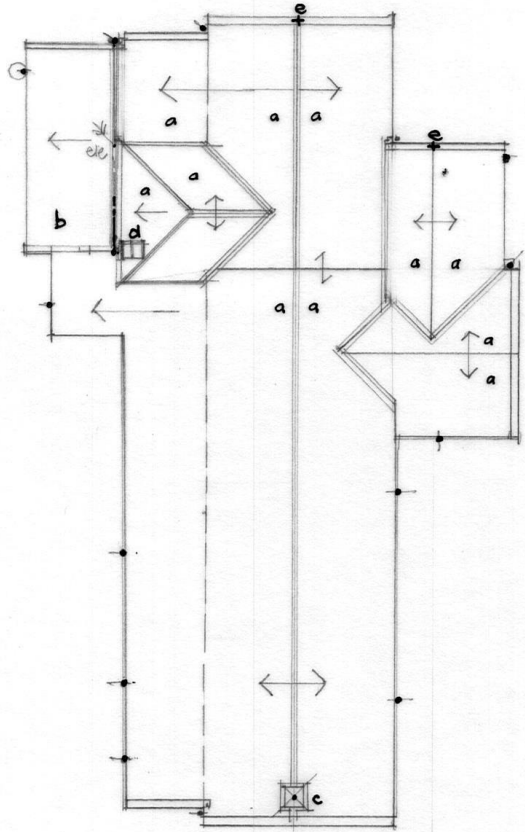
St Nicholas, Hedworth 1603
Roof Plan SK2
Nts Feb 2016

- a clay tiles.
- b felt covering
- c bellcote + spirelet
- d chimney.
- e stone cross.
