St Giles, Durham
County Durham, DH1 1QQ
DIOCESE OF DURHAM
Quinquennial Inspection

CONDITION SURVEY 2023

Prepared on behalf of the Parochial Church Council

by Ian Wells B Arch RIBA AABC

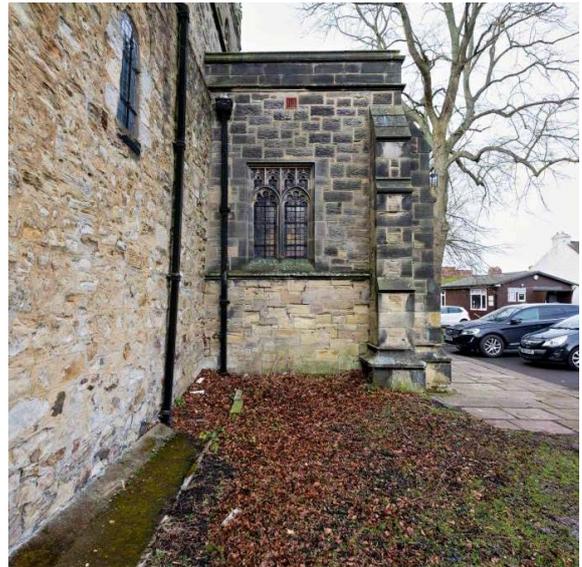
North Porch: east elevation

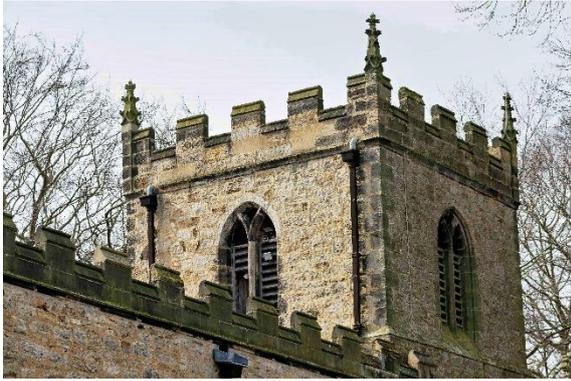
The tower. Overall, in poor condition with poor repointing and stone exfoliation. The tracery is particularly poor.

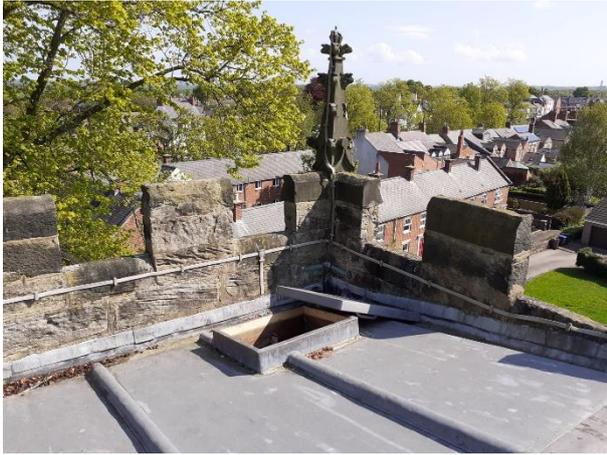
Tower Roof: access hatch in northeast corner

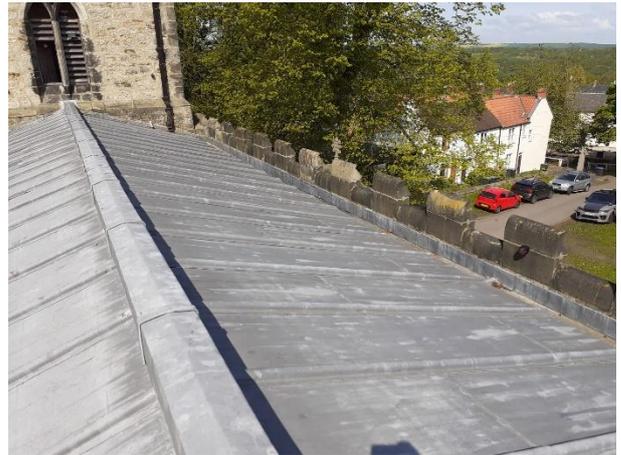
Nave roof north pitch

Most of the lead is of considerable age. There are many patch repairs, but these have been done well and the welding is not degrading.

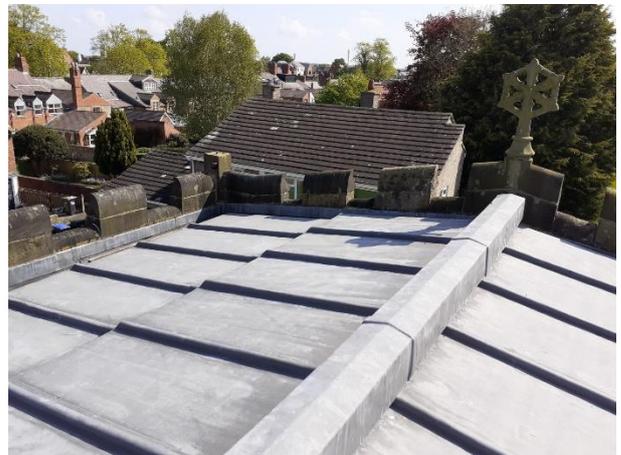
Chancel roof north pitch and ventilated ridge.

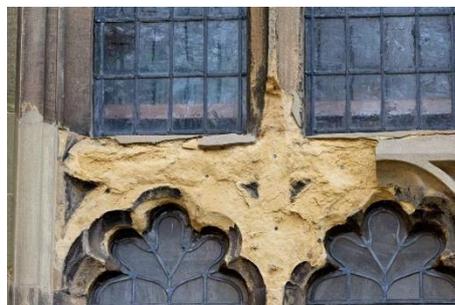
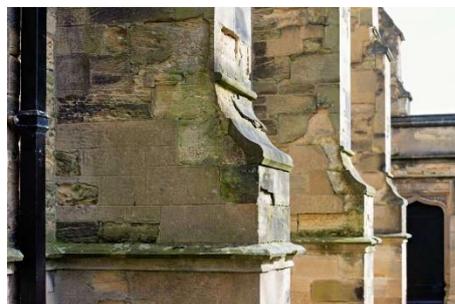
West Facing: the window in the east elevation. Large lumps of stone are falling off the tracery and being caught in the window protection mesh.

North Facing: The porch. Generally, less eroded than the south elements as better protected from the prevailing wind.

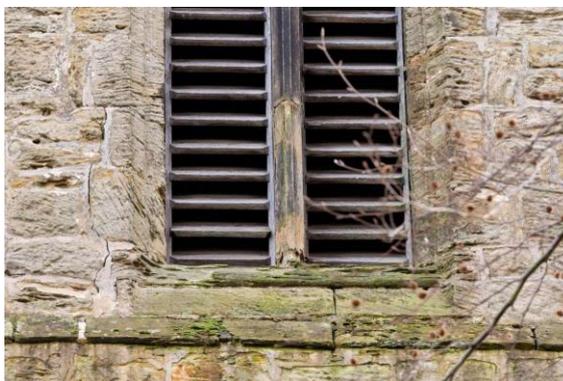
Stained Glass Leded Lights

The glass of the east window, over the altar, dates from 1898, it was made by the major London firm of Clayton and Bell. The glass itself appears to be in good condition but many shards of stone have been lost from the external tracery. This is clearly evidenced by the amount of stone fragments that have been caught in the external mesh protection.

The east window has mesh protection which is in acceptable condition. As reported above, it is catching sections of stone which have fallen off the tracery. When the stonework is carried out the condition of the mesh needs to be checked and repaired, as necessary.

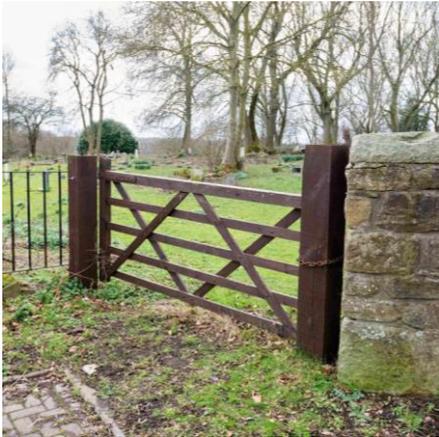
New gate to the 1927 churchyard.

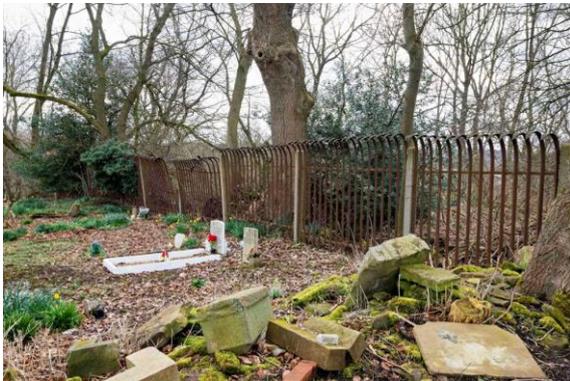
*Iron railings to the 1927 churchyard
which serve no purpose.*

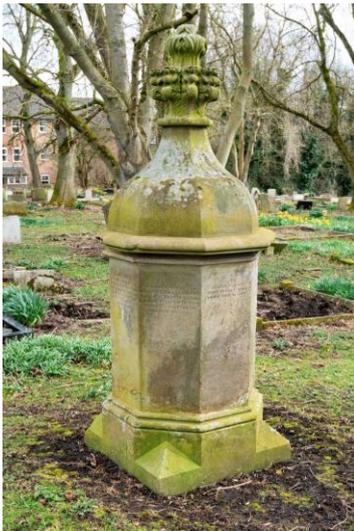
*Recently restored monument.
An excellent piece of work.*

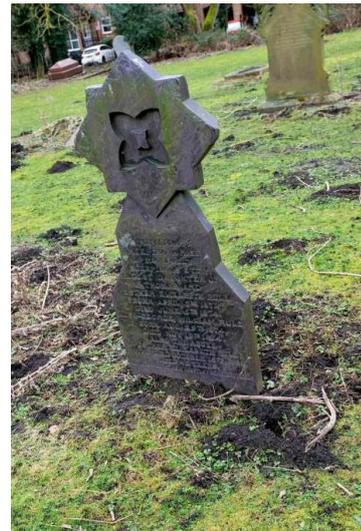
*1870 churchyard. The Rule family gravestone in slate
They were the Durham slate merchants.*

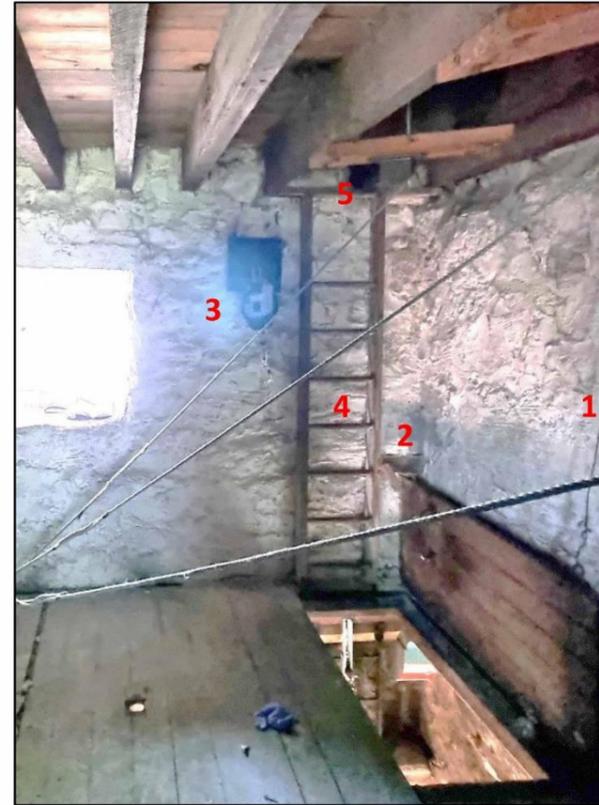
MUFFLING CHAMBER TIMBER LADDER

Hatch in open position

1. Wire of hatch counterbalance: retain.
2. Timber latch: retain and overhaul.
3. Fall arrest inertia reel: retain fixing plate, replace 6m reel with 10m reel
4. Wooden ladder: replace with galvanised steel.
5. Wooden fixing rail: replace with galvanized steel, fix only to timber joists.

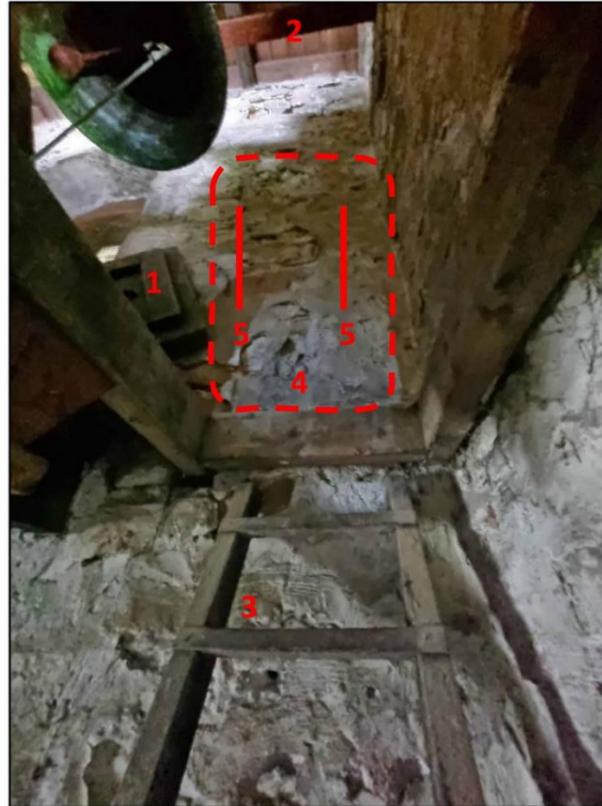
BELL CHAMBER FLOOR HATCH AND LADDER

Hatch in open position

1. Loose timber hatch: replace with counter balanced hatch to match existing on level below.
2. Fall arrest inertia reel salvaged from level below: fix to steel bell beam. 12mm hole to be drilled in beam.
3. Wooden ladder to be replaced with galvanised steel: Fix to timber rail at top and floor at bottom.
4. Existing stone wall: Remove 2m² of lime render, exfoliate stone faces and repointing in NHL 3.5 Lime mortar.
5. Fix new galvanised steel hand grab rails to wall face: fixings to be stainless steel resin anchors into the mortar joints.
