**Quinquennial Inspection Report
The Parish Church of St. Thomas, Eighton Banks
Archdeaconry of Sunderland
Diocese of Durham**

David Jowett - Architect, BA, DipArch, RIBA
25 Roseworth Avenue
Gosforth
Newcastle upon Tyne
NE3 1NB
Tel: 07788 710204
email: david@davidjowett-architect.co.uk

16 February 2023

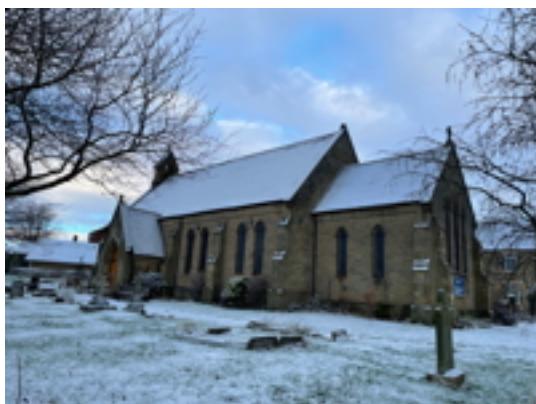
South roofs generally appear in satisfactory condition with one slipped slate to Nave south elevation west end. Slipped slates to Porch east and west elevations. Some slipped slates to north elevation west end at eaves. North Vestry and Chancel roofs in satisfactory condition. Valley gutter between vestry and nave not visible from ground level.

South Roofs

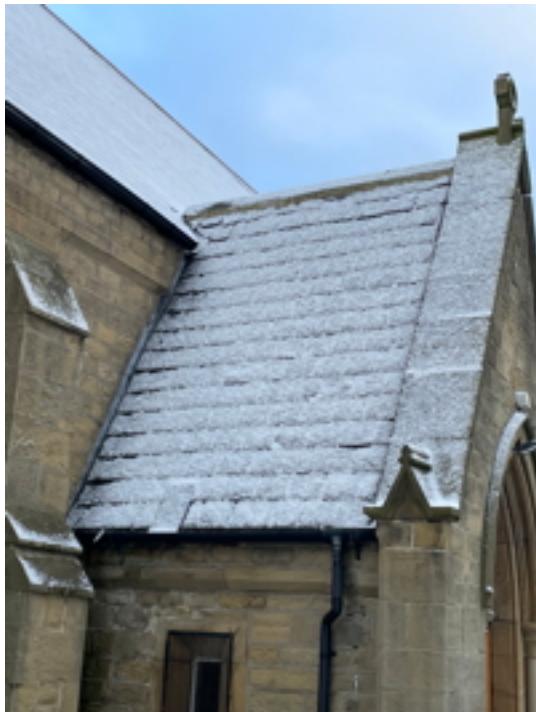
Porch West Roofs with slipped slates at eaves and ridge

Generally inspect roofs at close quarters by qualified roofer and carry out repairs as recommended including inspection of hidden valley gutter.

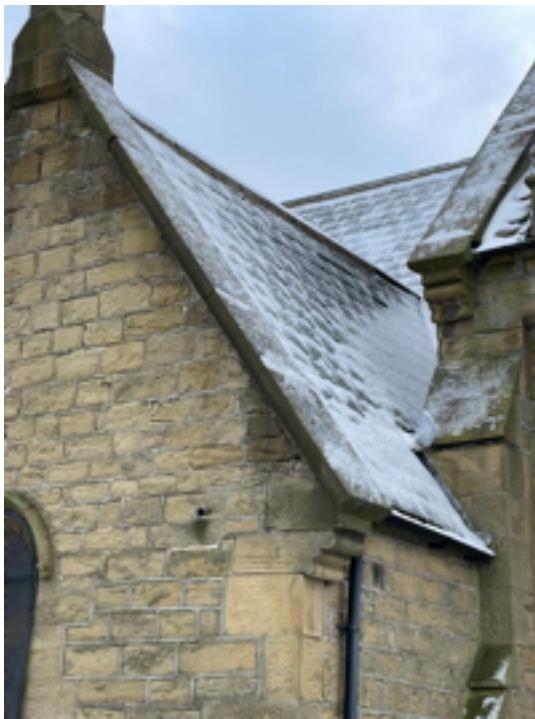
Vestry West Roof with hidden valley gutter

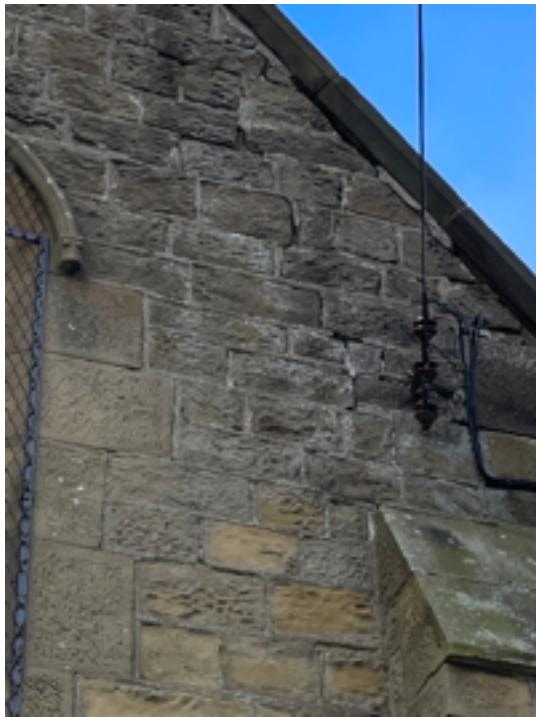
Chancel east elevation north side open joints

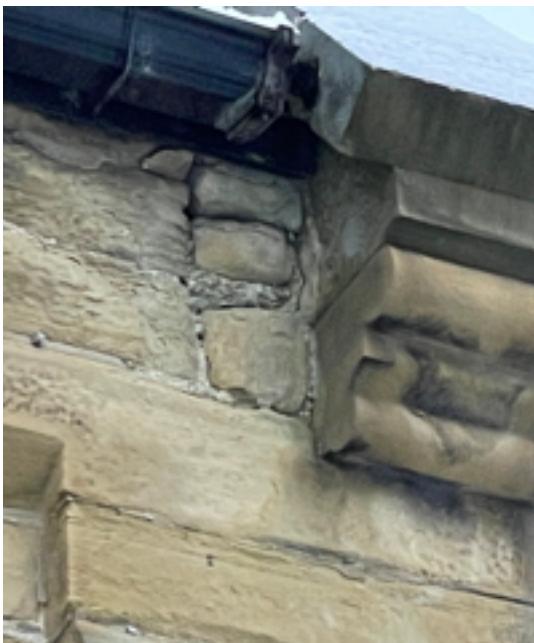
South elevation east end open joints

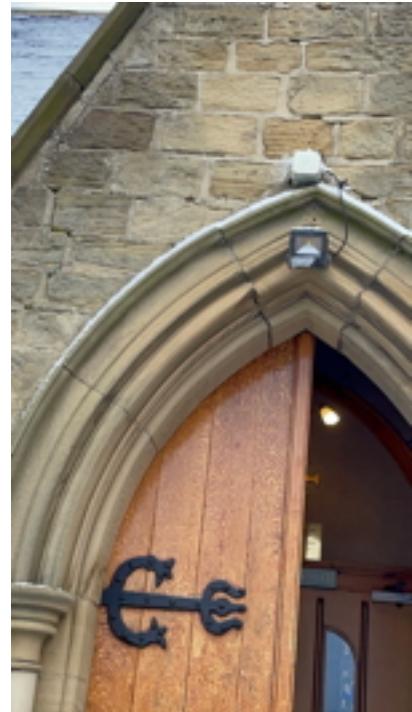
Vestry south elevation open joints and historic movement to keystone

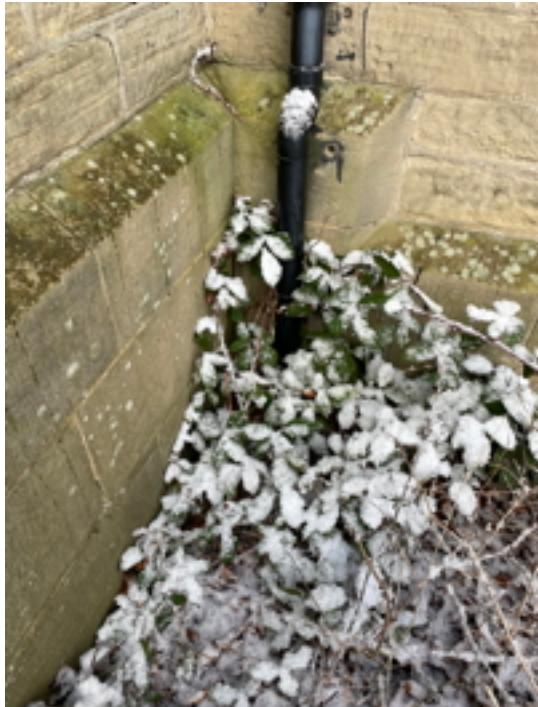
Sump covered with foliage

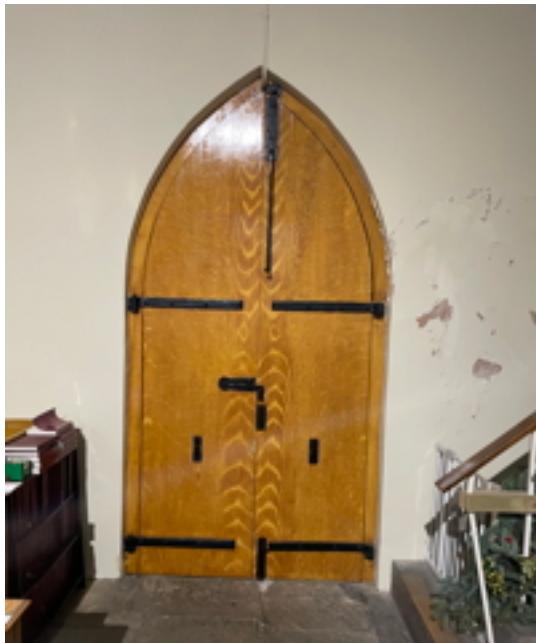
South Lobby Doors

All in good condition.

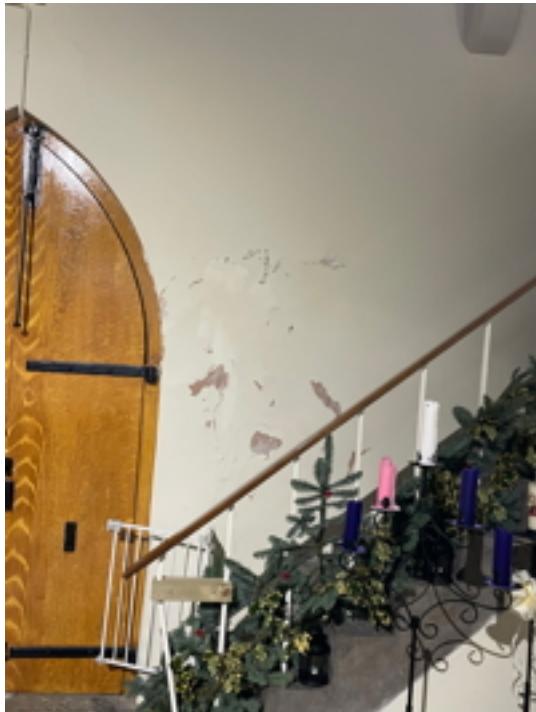
Damp above Gallery Staircase

An historic movement crack to the south wall window jamb does not appear to have deteriorated since the previous report, and has been infilled as part of the recent redecoration works. Damp to wall above gallery staircase has reappeared due to incorrect alignment of the gutter externally. The Nave east wall is streaked which appears to be from condensation. There is minor flaking to the chancel east wall paintwork at low level.

Allow building to ventilate (opening doors) to remove moisture laden air and so prevent condensation. Cost Band 1 – £0.00-1,999.

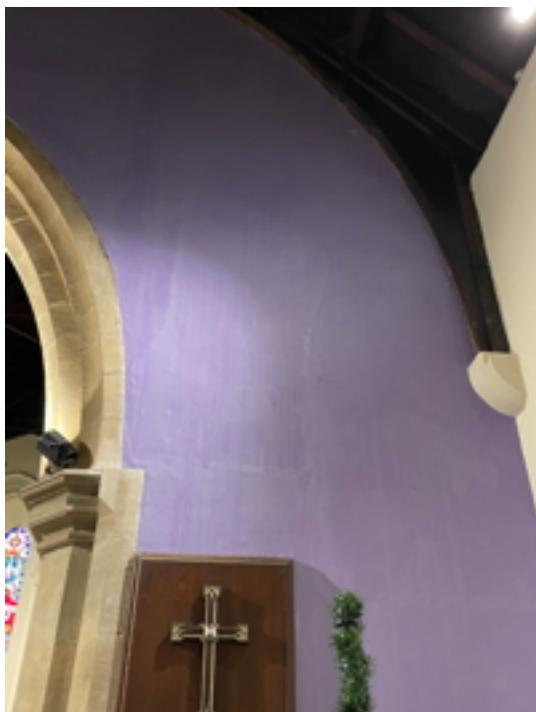
Nave east end streaking to wall

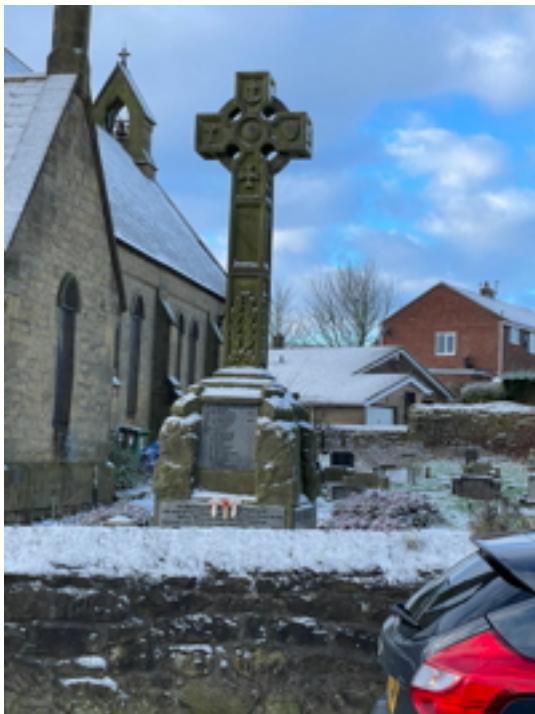
WWI Memorial

All well cared for. The war memorial to the north-east of the church has been inappropriately repointed with cement-rich mortar.

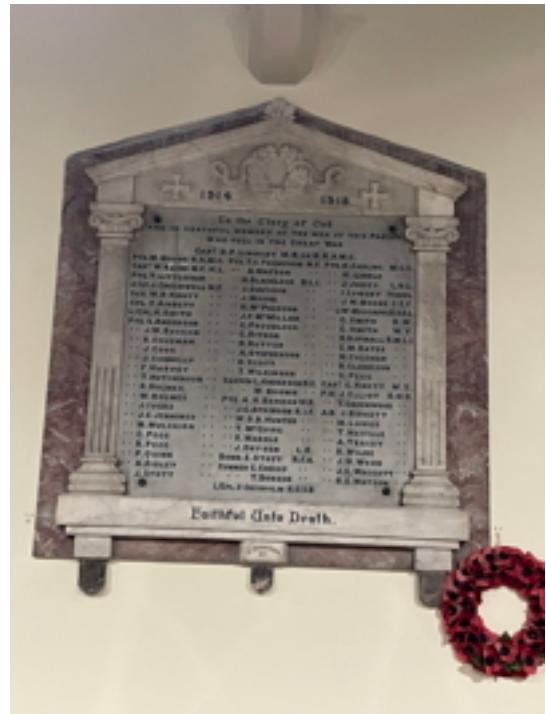
WWI Memorial Nave north wall

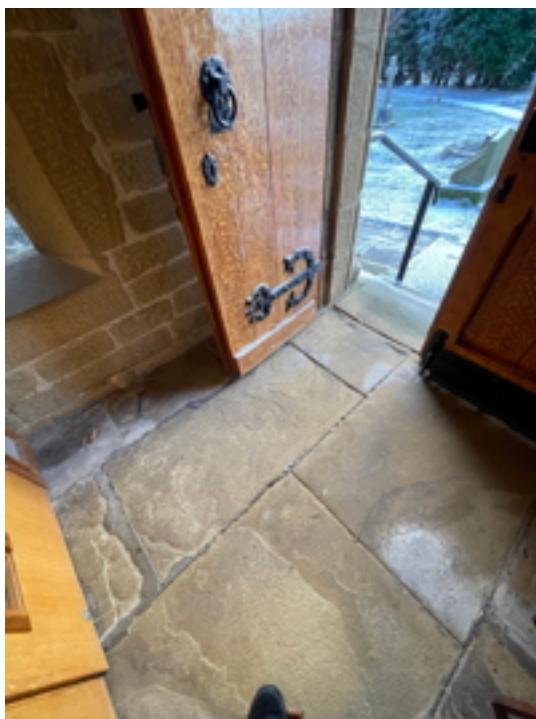
South Porch looking south east

South Porch condition is generally satisfactory. However the walls have been partially repointed with inappropriate cement-rich mortar, which has been poorly executed and incorporates inappropriate mortar joints. Rust jacking of the lower west external door hinge has caused a failure to the sandstone which requires appropriate indent repair.

Clean rust from wrought iron hinge and indent repair associated damaged sandstone. Cost Band 2 – £2,000.00-9,999.

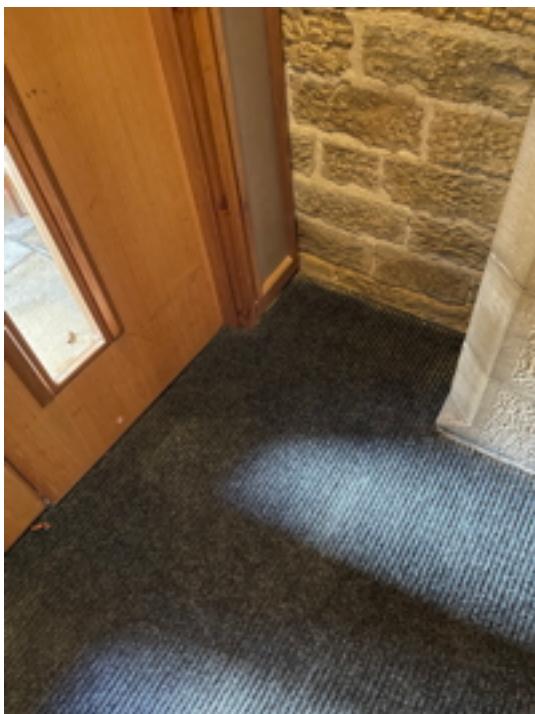
South Porch Lobby condition is generally satisfactory. However the walls have been partially repointed with inappropriate cement-rich mortar, which has been poorly executed and incorporates inappropriate mortar joints.

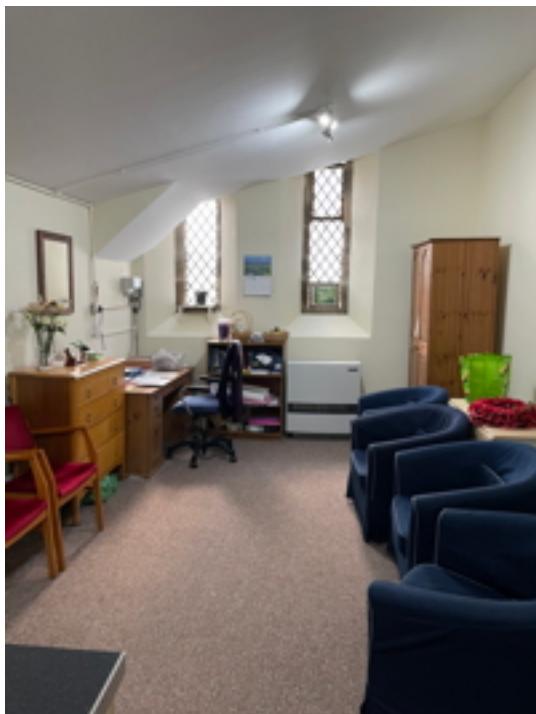
Meeting Room looking South

Meeting Room and Kitchen condition is generally satisfactory. There is evidence of loose boarding beneath the carpet (it is assumed this is loose plywood sheeting underlay). Ventilation grilles, located at high level on the west gable, are becoming infilled with emulsion paint and not providing adequate ventilation.

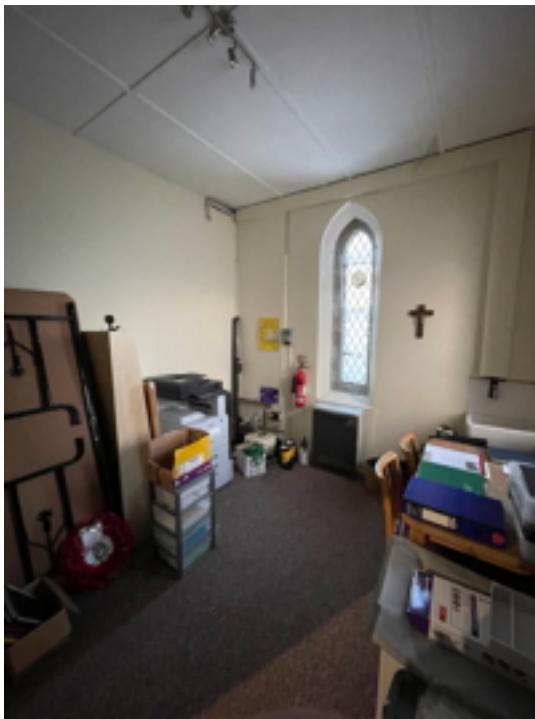
Vestry looking north west

The Vestry condition is generally satisfactory. There is evidence of loose floor boarding beneath the carpet. The electrical cupboard is in poor condition with missing panelling and binding doors. The gas meter is clumsily located.

Make good or replace the electrical cupboard. Cost Band 1 – £0.00-1,999.

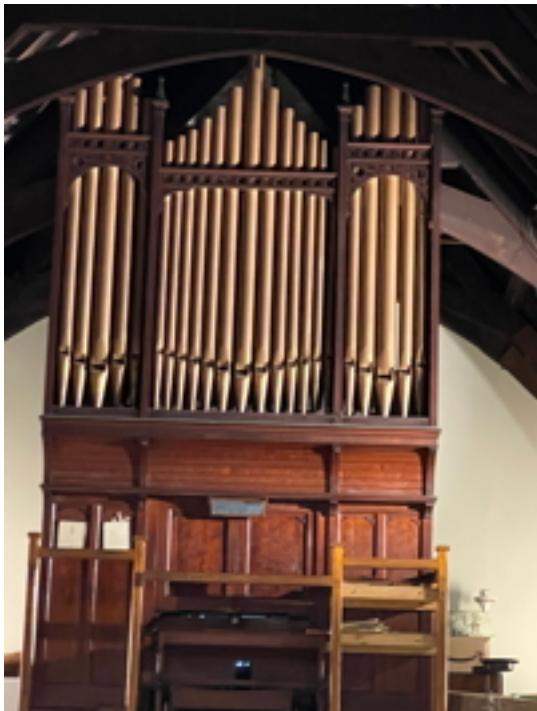
Organ reported to be in working order, although the Organ Tuner's Book was not to be found.

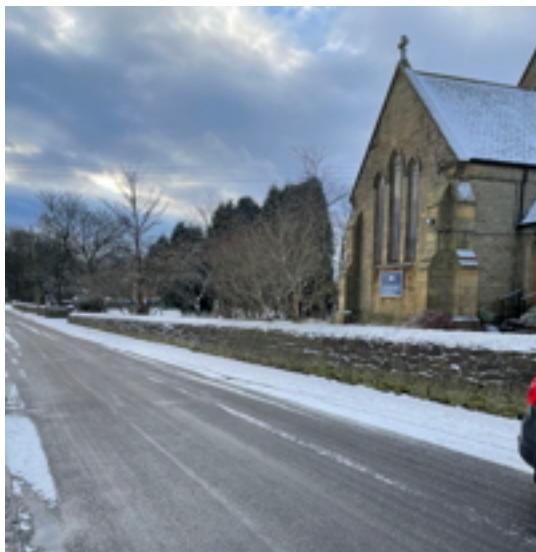
East wall

The majority of the walling is generally in a reasonable state of repair although there are a few areas that require repointing. Small areas of the west wall have loose stones and vegetation growing from the wall due to lack of maintenance.

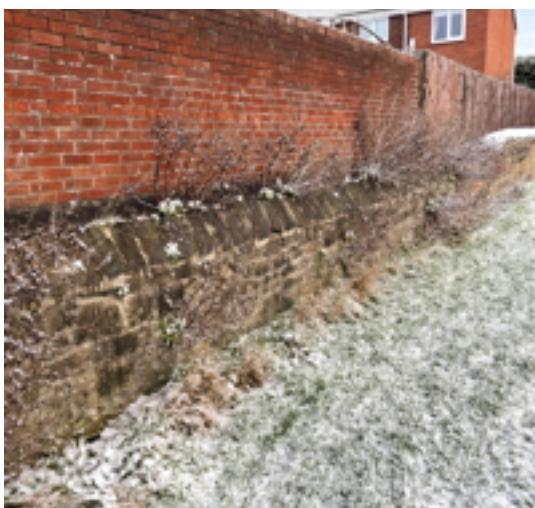
West wall with vegetation

Repair west wall, pointing loose stones with lime mortar and removing vegetation and repointing with lime mortar. Cost Band 1 – £0.00-£1,999.

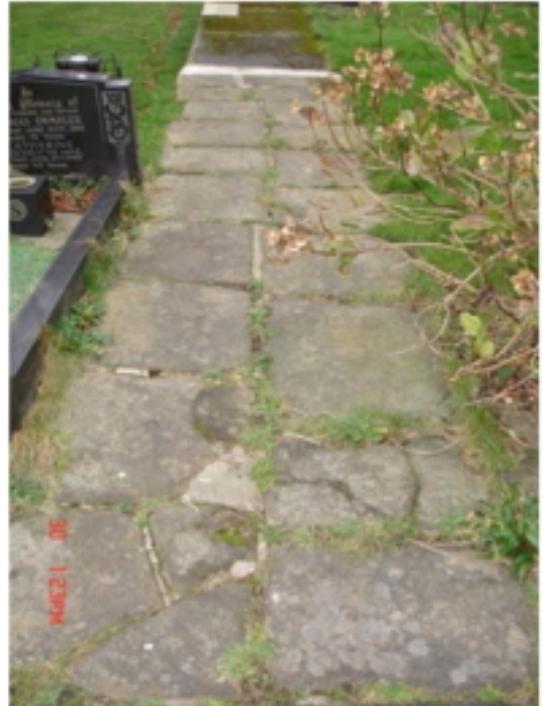
Flagged pathway to south Porch

The grass is well maintained. The pathway from the east gate appears to be in reasonable order. Tarmaced pathway to north shows signs of surface deterioration and, in places, has heavy moss growth. Flagged pathways have several uneven flags.

Resurface areas of deteriorating pathways and level flags. Cost Band 1 – £0.00-£1,999.

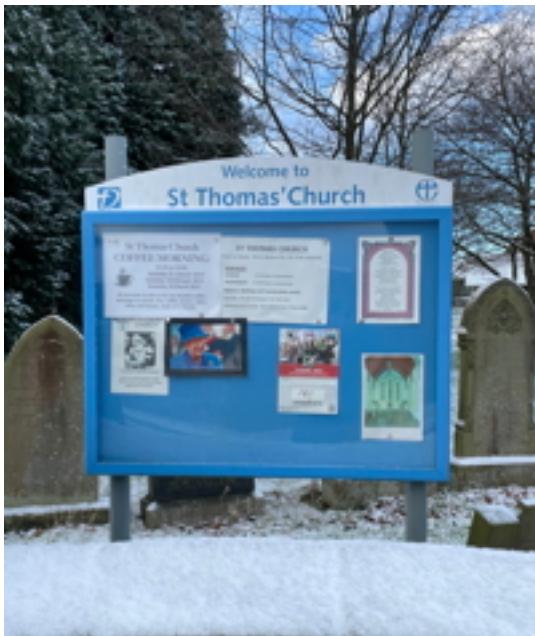
The Noticeboard on the east edge of the site is generally in good condition and is informative. The second Noticeboard is in need of replacement as the top lettering has all faded.

East boundary noticeboard

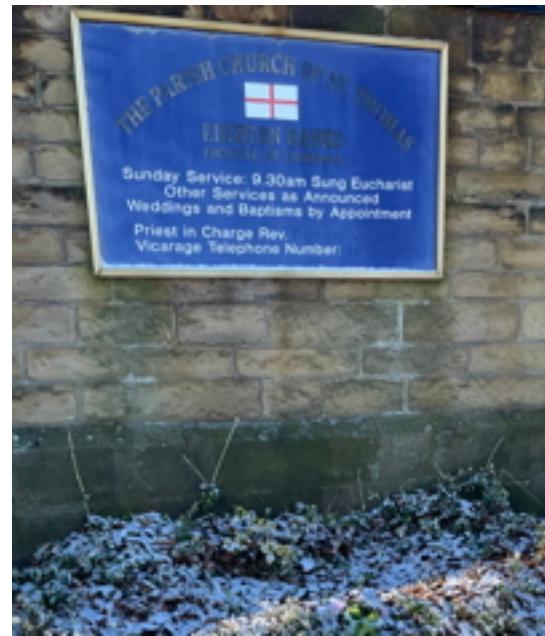
East elevation noticeboard

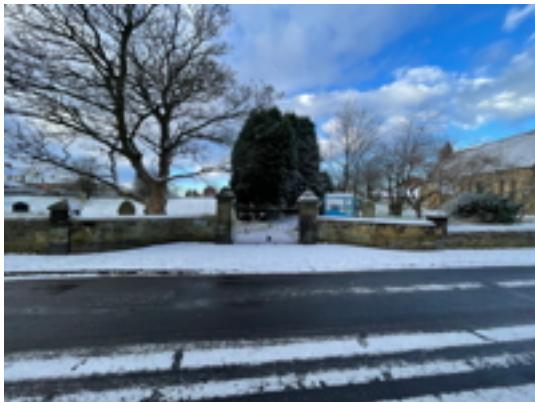
East boundary trees

The condition of the trees appears satisfactory.
