**Quinquennial Inspection Report  
Christchurch, Felling  
Deanery of Gateshead  
Diocese of Durham**

David Jowett - Architect, BA, DipArch, RIBA  
25 Roseworth Avenue  
Gosforth  
Newcastle upon Tyne  
NE3 1NB  
Tel: 07788 710 204  
email: [david@davidjowett-architect.co.uk](mailto:david@davidjowett-architect.co.uk)

13 November 2025

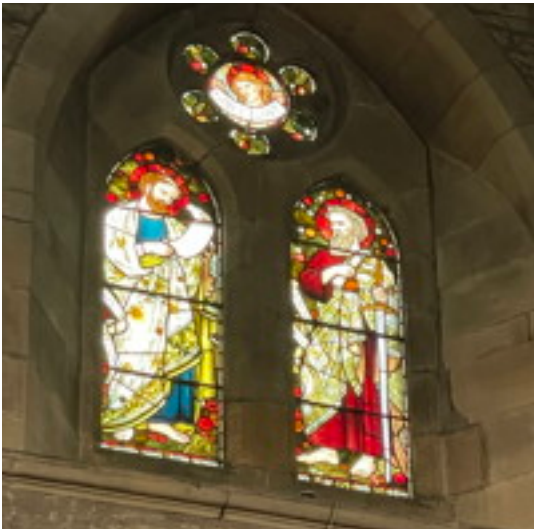
**North Clerestory Stained Glass**

- (i) (ii) Repair all broken or damaged leaded lights to north clerestory. **Outstanding**

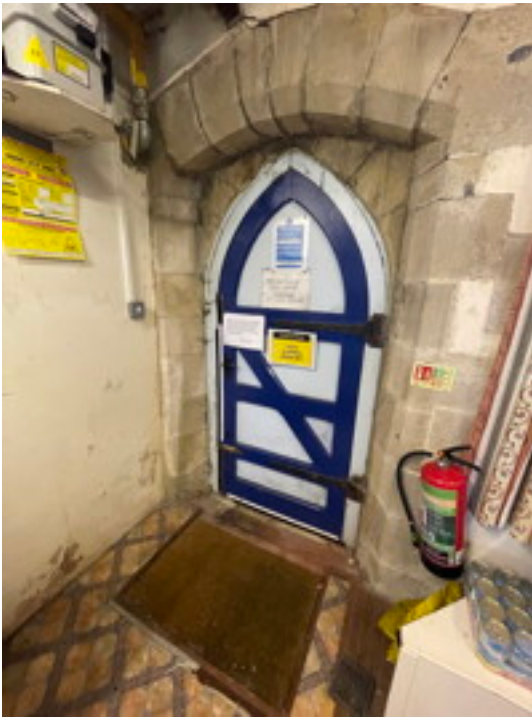
**Vestry Store Looking North West**

**Vestry Store Looking South West**

**Vestry Store East Door**

The vestry store is all generally in fair condition accept for the ceiling which shows signs of rot. The priest in charge reported that the joist ends had been replaced some years ago and the roof repaired following water penetration. Unless there is still water penetration due to the very low pitch, approx 14 degrees, causing wet rot, there is real possibility of dry rot which like a moisture content of around 20%

Arrange a timber survey with a reputable timber preservation company to establish whether the timbers are suffering from wet rot or dry rot. Cost Band 1– £0.00-£1,999.

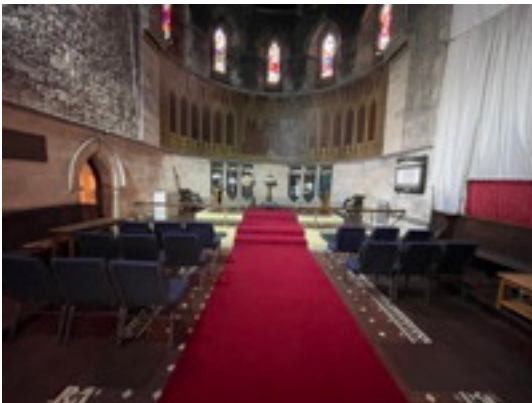
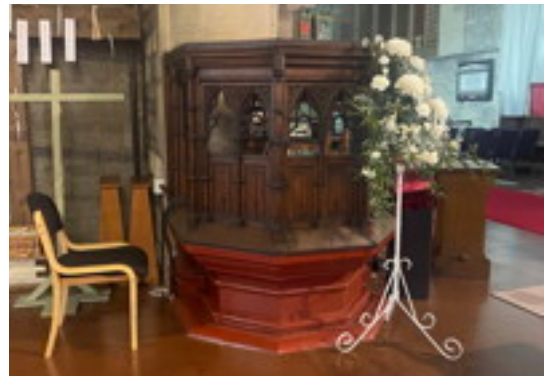
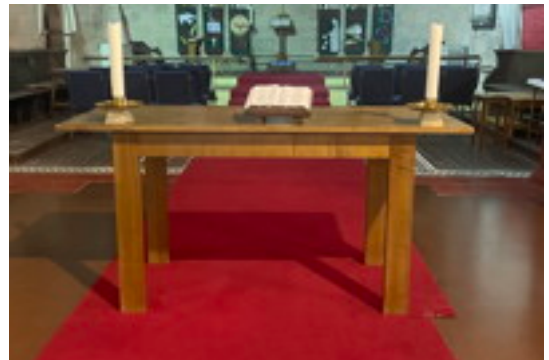
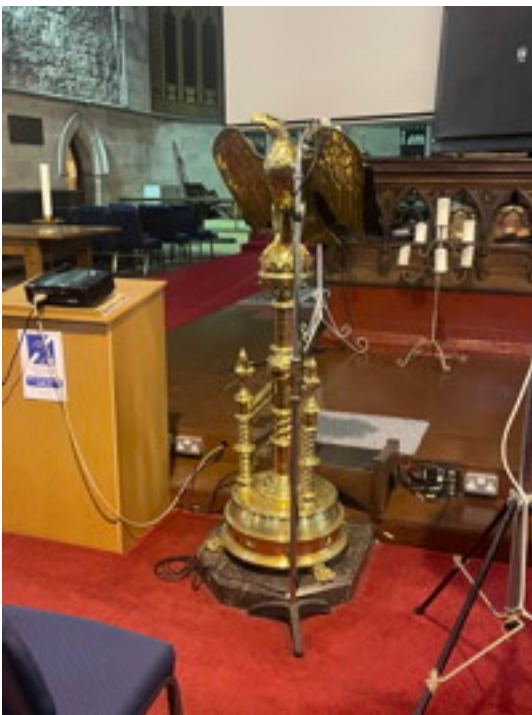
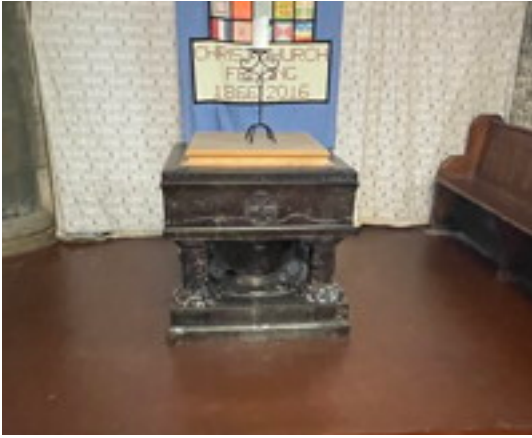
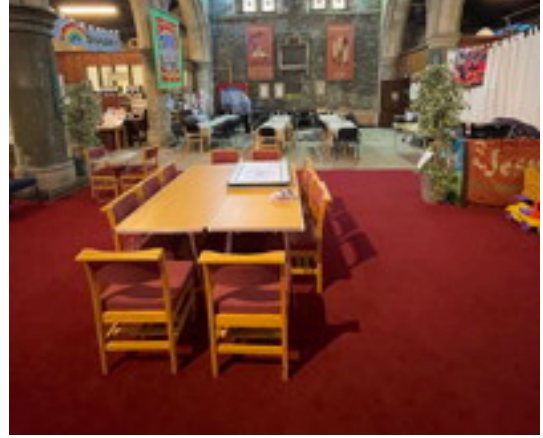
**Chancel and Sanctuary**

**Pulpit**

**Altar**

**Brass Lectern**

**East Nave Seating**

**Font**

**West Nave Tables and Chairs**

All are in good condition.

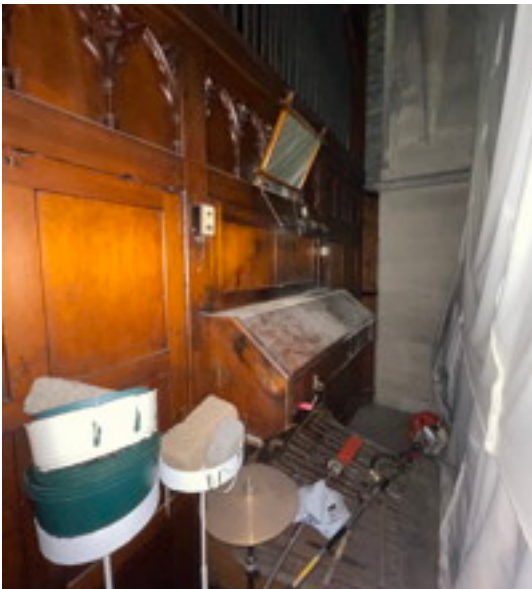
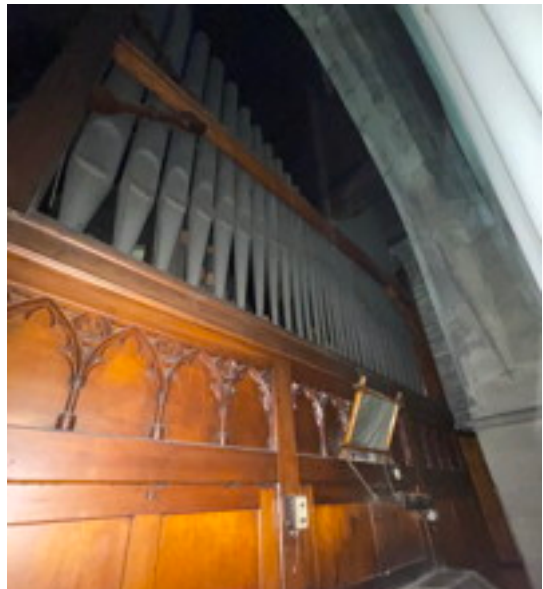
**Organ Console**

**Organ Pipework**

The organ has not been used for over 25 years and is screened off by curtains to the north and west. In its present condition it is unplayable and will require a full rebuild before it could be used. It is also noted that this instrument, when in playing order, was considered rather small for the size of the building. Any rebuilding might therefore have to include the introduction of additional stops. The blower is mounted in a small unsightly enclosure on the south wall which would be better removed.

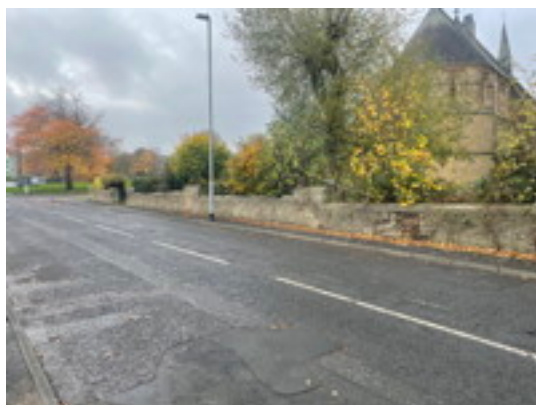
**East Boundary Wall**

**East Boundary Wall Entrance**

The walls are generally in satisfactory condition with some major exceptions. A very large section of wall has collapsed along the southern boundary following a tree falling. Neither the council or the insurers will accept responsibility. A considerable amount of the stone has been removed. To the eastern elevation, a section of wall has started to collapse due to tree growth within the wall. Similar tree growth has occurred at the south east corner.

Reinstate railings to lower sections of walls and gates to entrance to improve security and reduce vandalism prior to repair works to previously vandalised areas. Cost Band 4– £30,000 - £50,000.

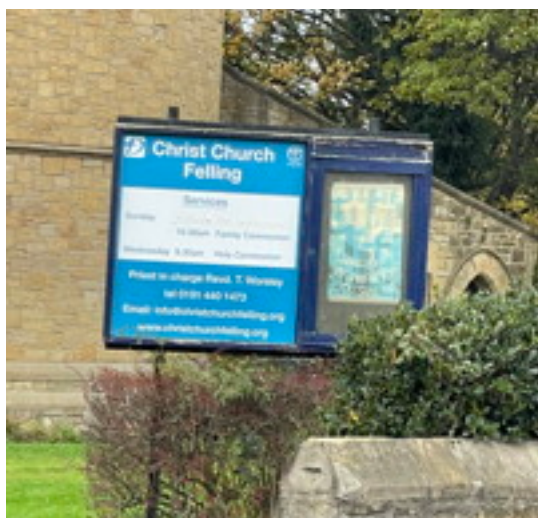
At the south east corner is a noticeboard.

The noticeboard is in fair condition.

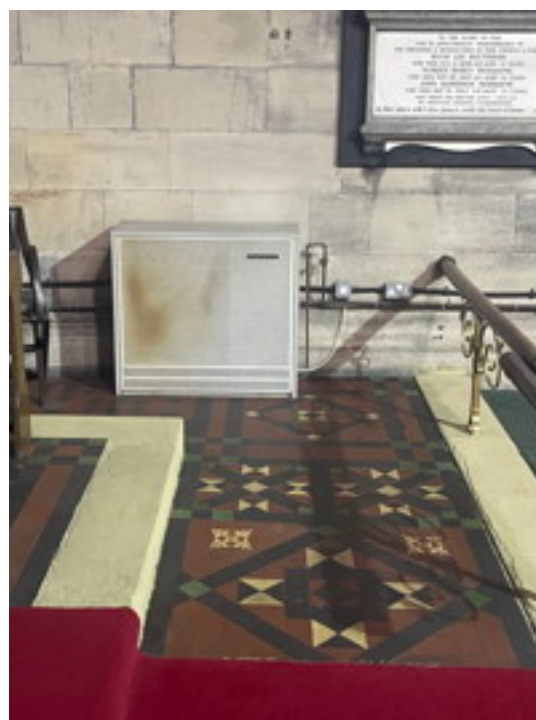
**Vestry Store Boiler**

**Typical Church Heater**

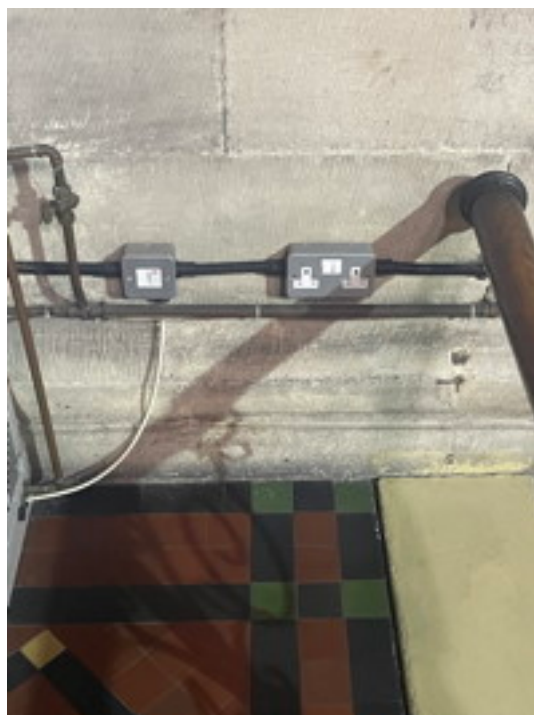
**Incoming Electric Supply**

**Typical Sockets**
