**Quinquennial Inspection Report
Parish Church of St Andrew Leam Lane
Diocese of Durham**

Report prepared by

David Jowett - Architect, BA, DipArch, RIBA
25 Roseworth Avenue
Gosforth
Newcastle upon Tyne
NE3 1NB
Tel: 07788 710 204
email: david@davidjowett-architect.co.uk

27 February 2023

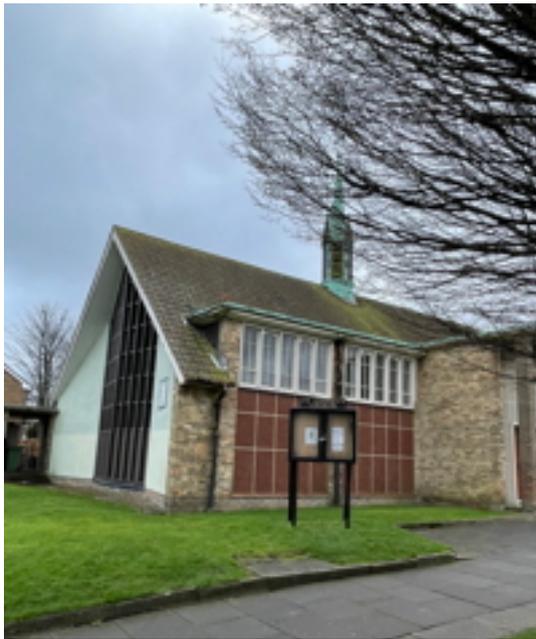
**Pantile and clerestory roofs
north east corner**

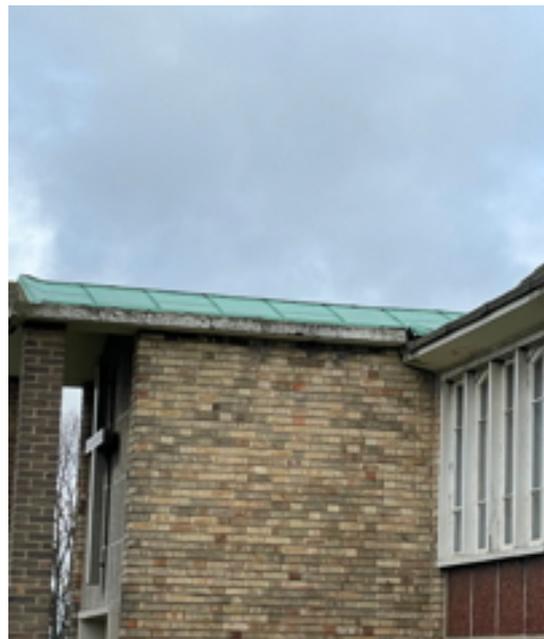
Porch roof west elevation

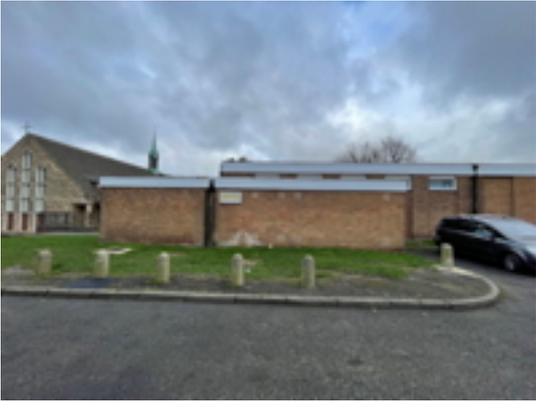
Hall roof west elevation

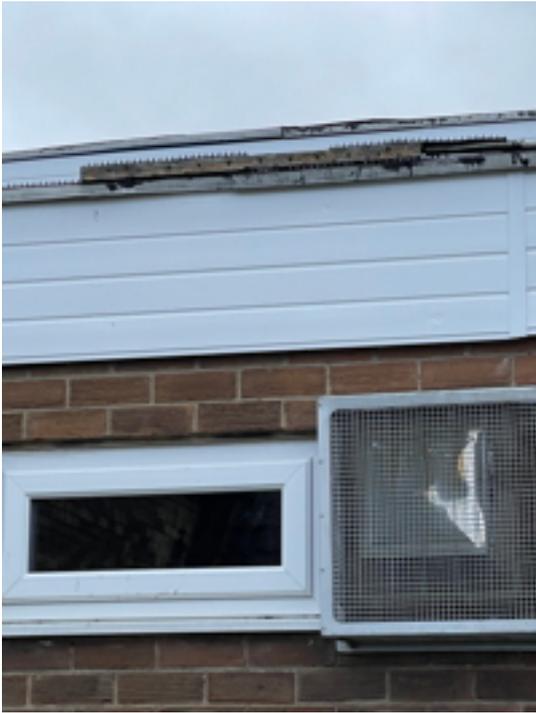
Hall fascia north elevation

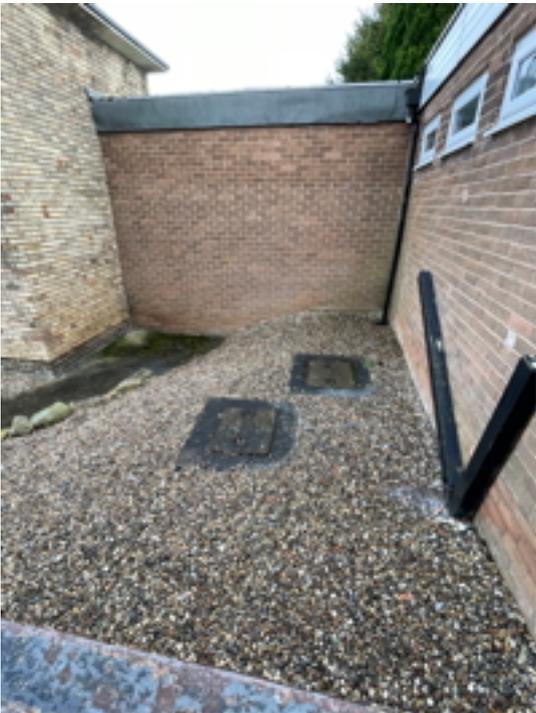
**Link Corridor roof west
elevation**

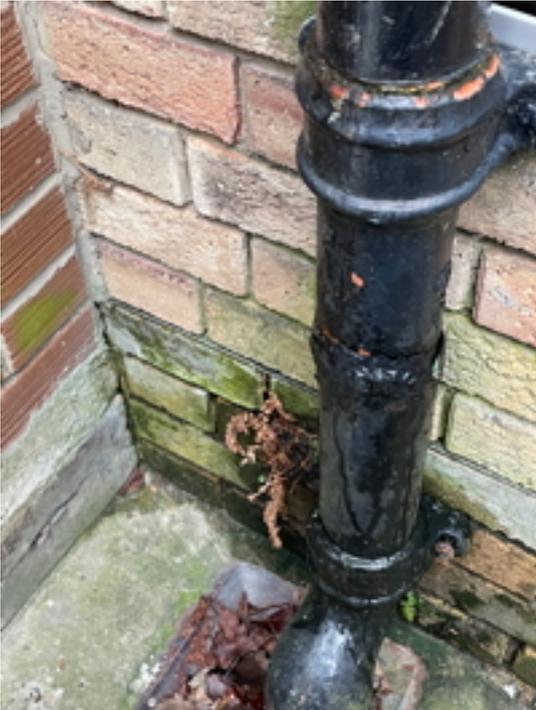
Split cast iron rainwater pipe to Hall

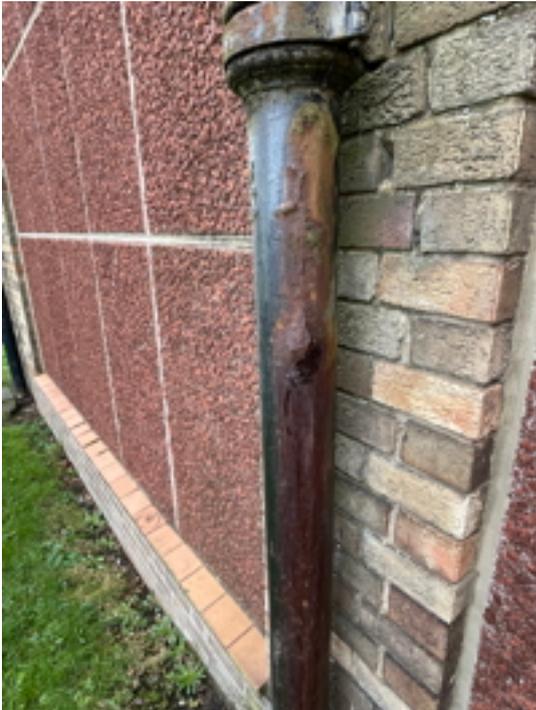
Split cast iron rainwater pipe to Church

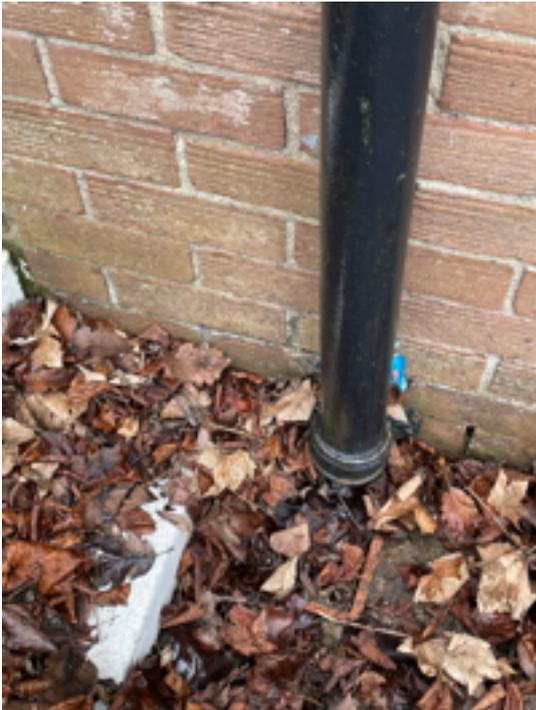
Typical blocked gully to Courtyard Garden

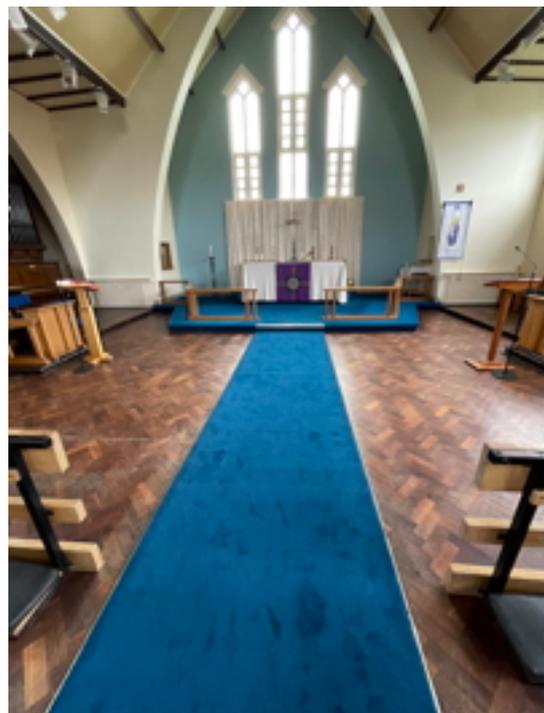
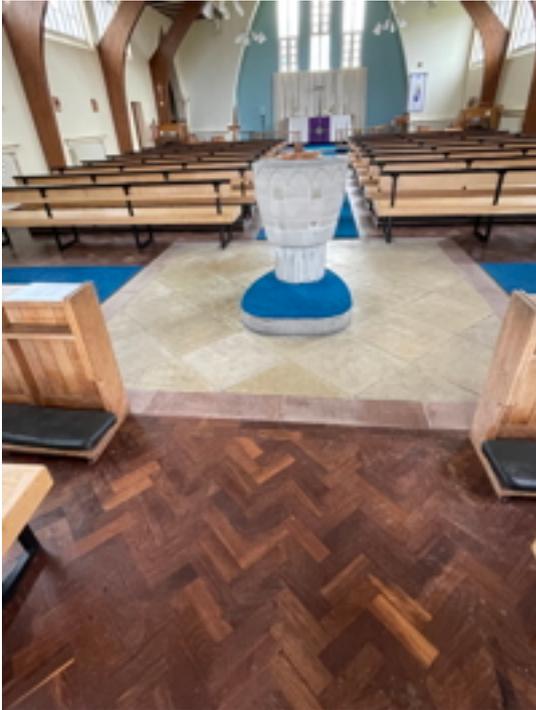
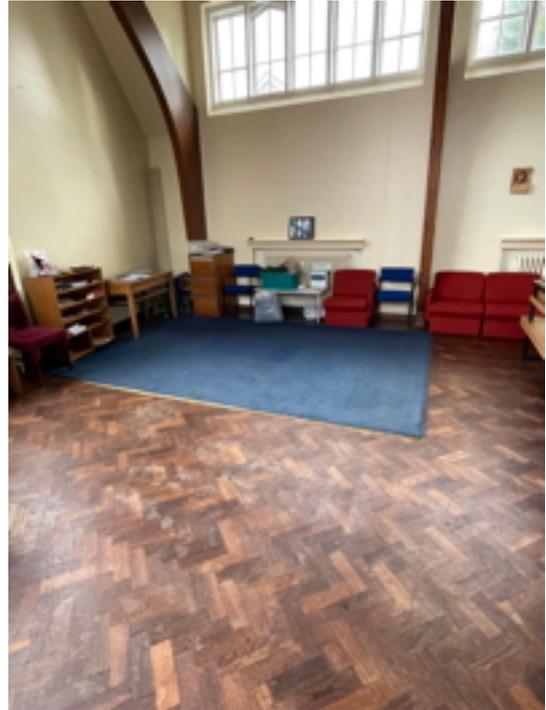
Floors are all in satisfactory condition.

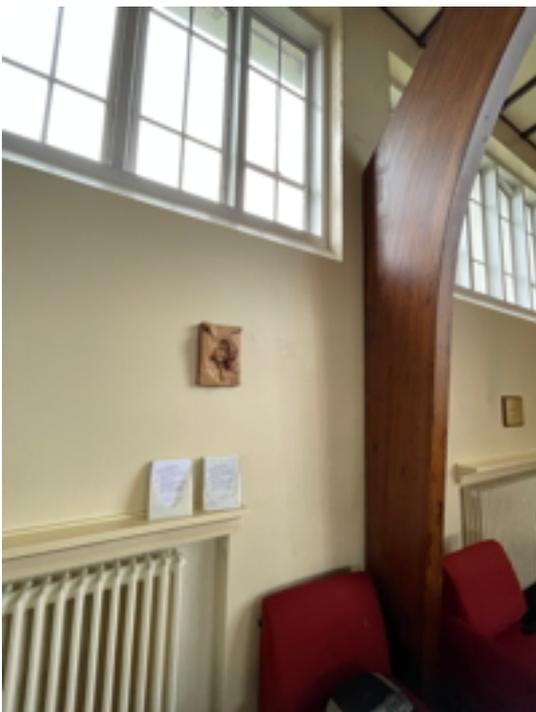
Salts to plasterwork north wall east of North Porch

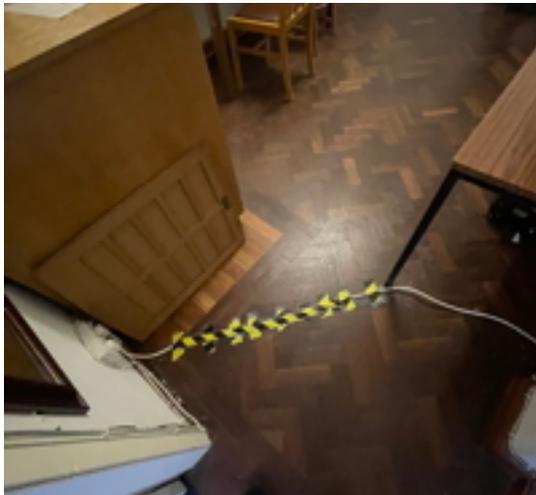
Cabling running across floor

The Vicar's Vestry is generally in satisfactory condition. However the cabling that runs across the floor is an obvious trip hazard.

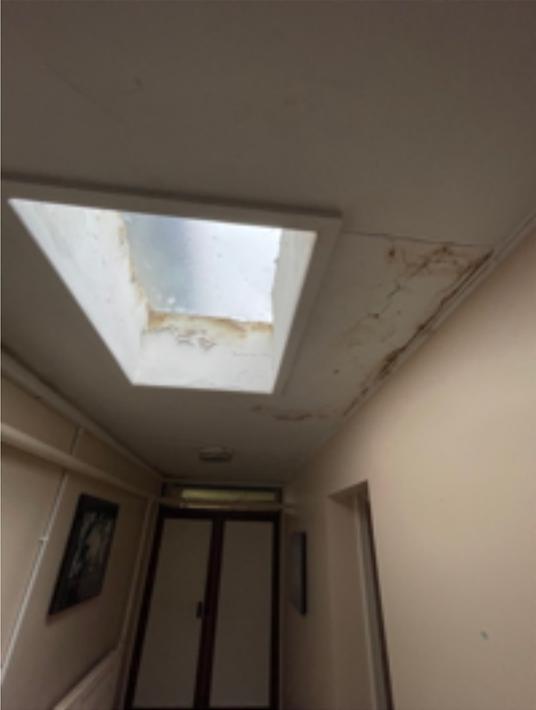
East Corridor rooflight

The Meeting Room Kitchen is generally in satisfactory condition with the exception of the ceiling where there is evidence of water ingress around the rooflight and above the east doors.

Inspect roof as item 9.1 and repair as necessary, then redecorate. Cost Band 1 – £0.00-1,999.

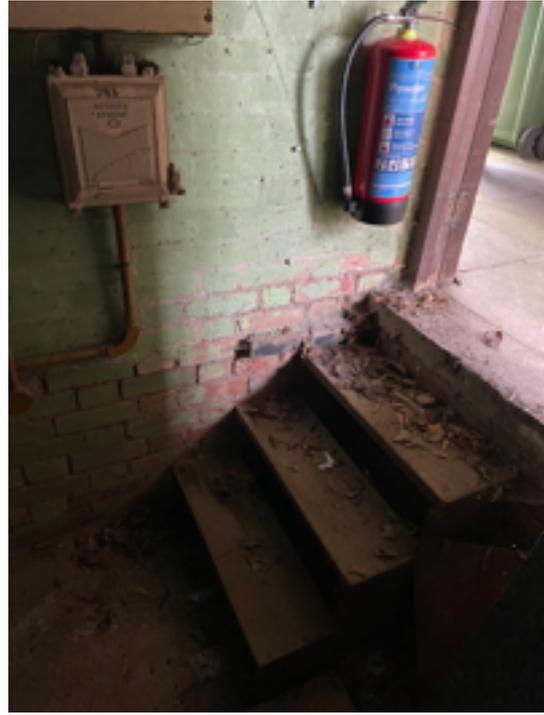
Heating Chamber steps

The steps have no handrail. There is some cracking to the concrete ceiling/roof.

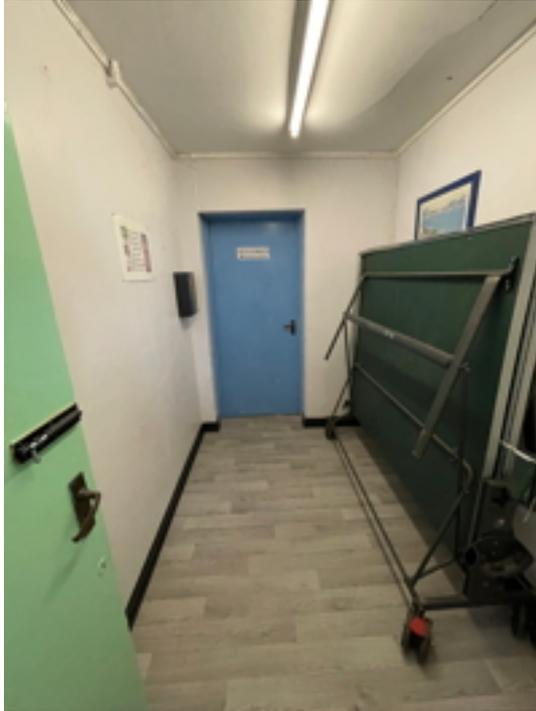
The Link Corridor/Hall Lobby would benefit from redecoration. There is a large crack and warping to the ceiling probably caused by water ingress. A table tennis table is stored in the Lobby and would be better kept in the extensive store areas provided. The electrics should be boxed in to prevent tampering.

Redecorate Link Corridor/Hall Lobby including repair to cracked ceiling. Cost Band 1 – £0.00-1,999.

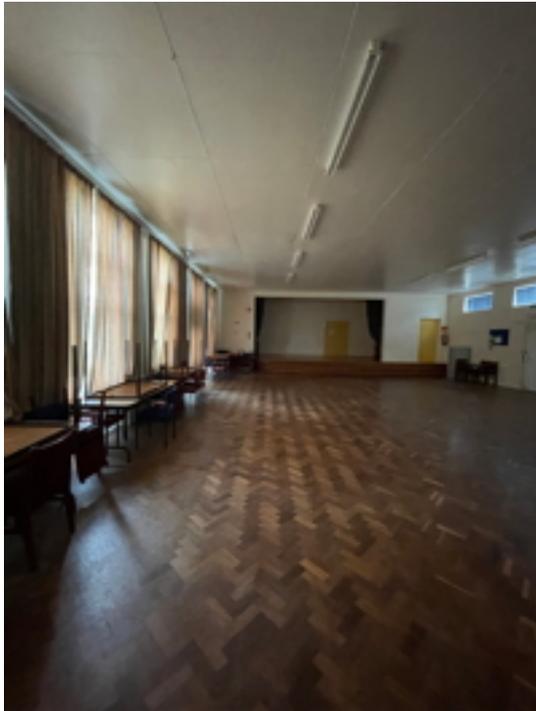
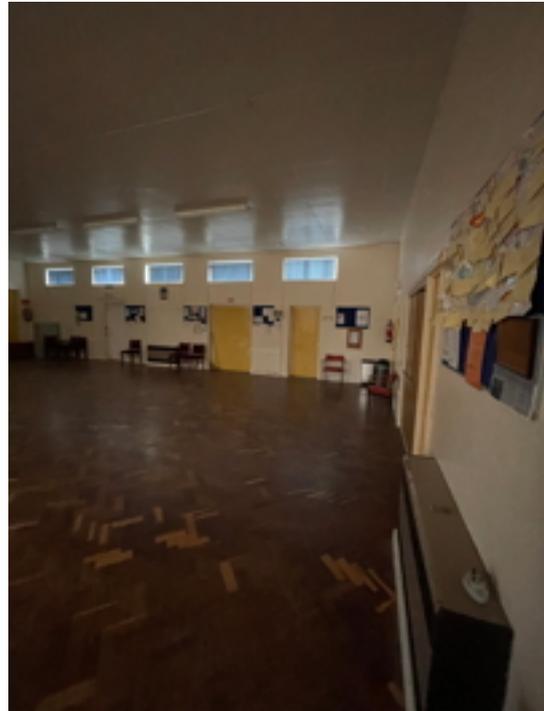
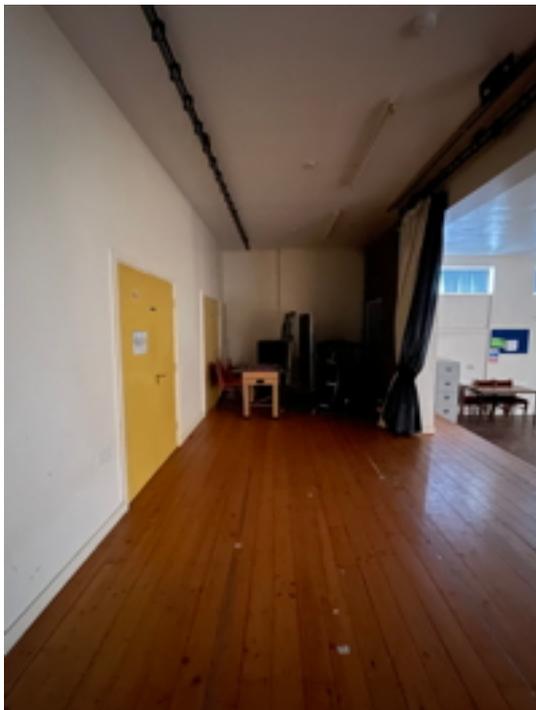
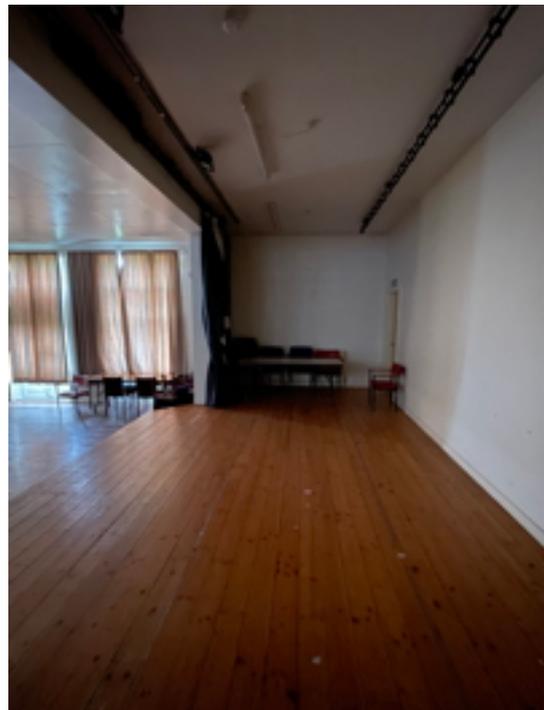
The Hall appears to be shabby and would benefit from redecoration. External doors should be replaced as noted in section 9.5. Some ceiling boards stained and warped, probably caused through water ingress.

Redecorate Hall including repairs to ceiling. Cost Band 2 – £2,000.00-9,999.

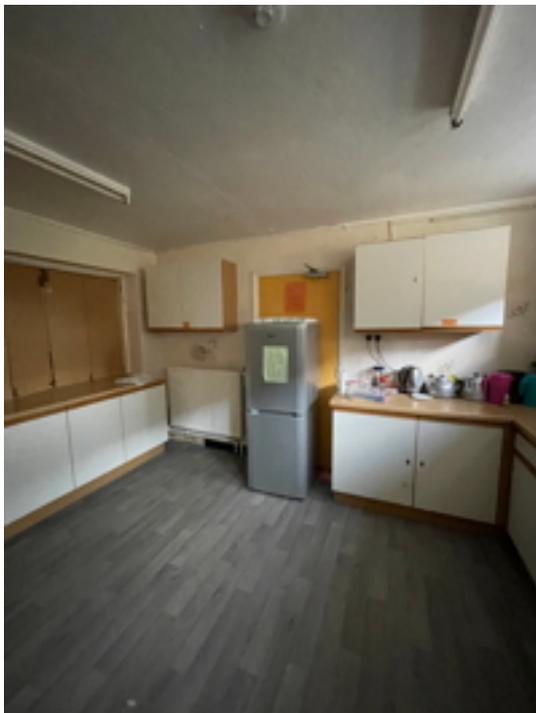
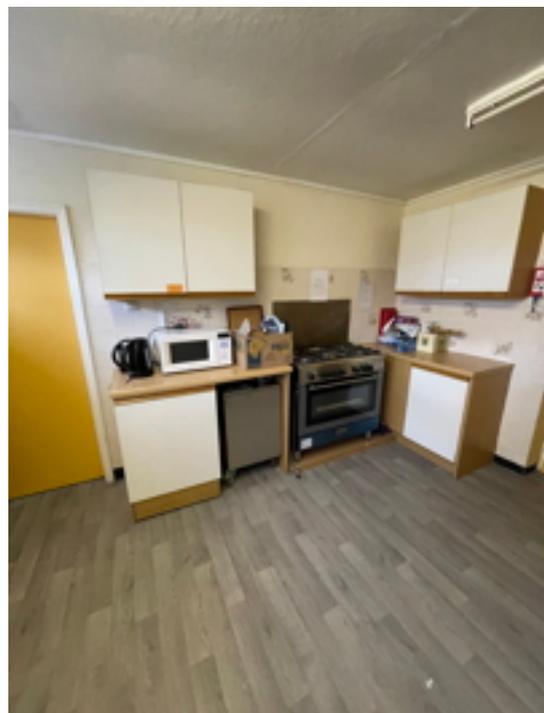
The Hall Kitchen would benefit from redecoration. One window broken. Fridge freezer blocks door to Main Hall Entrance Lobby.

Replace broken window pane with laminated glass as item 9.5. Cost Band 1 – £0.00-£1,999.
Rearrange Kitchen to unblock doorway. Cost Band 1 – £0.00-£1,999.

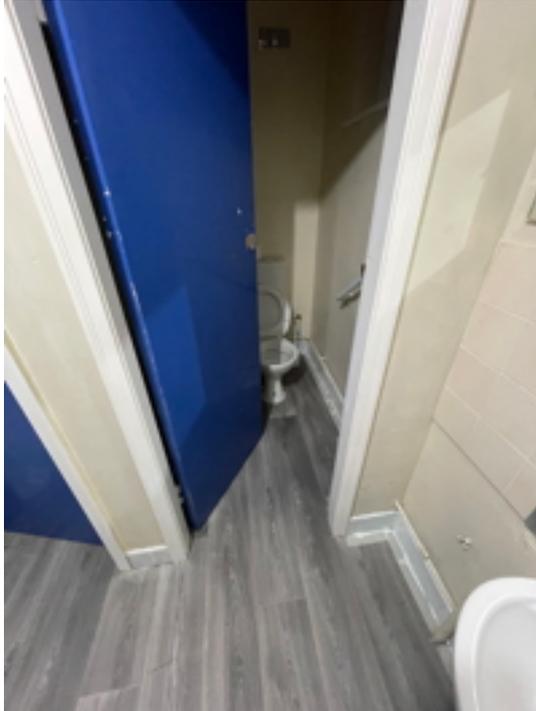
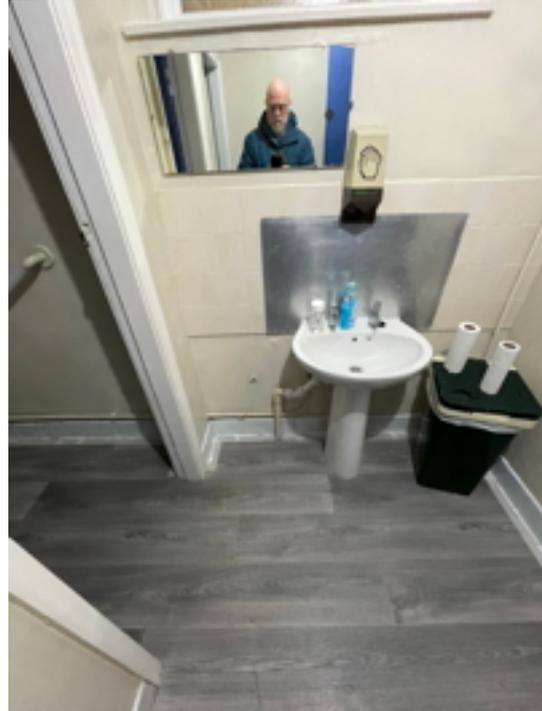
The Male WC does not provide an accessible WC nor baby-change facilities. One window is broken.

Replace broken window pane with laminated glass as item 9.5. Cost Band 1– £0.00-£1,999.

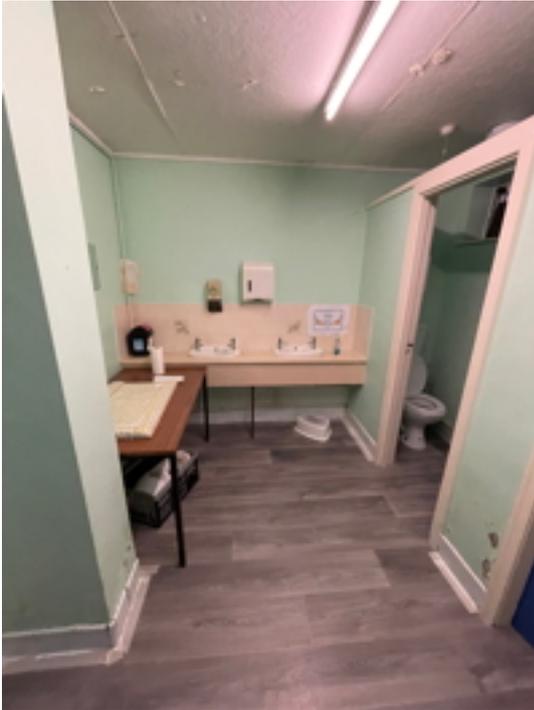
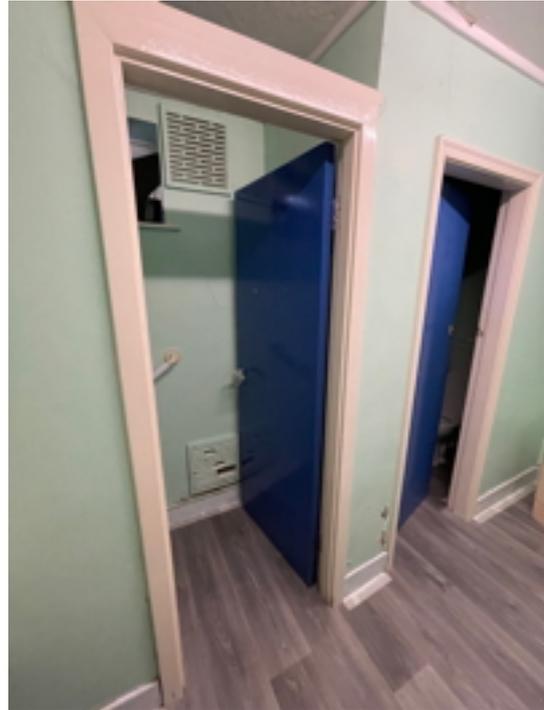
The Female WC does not provide an accessible WC nor inbuilt baby-change facilities. One window is broken.

Replace broken window pane with laminated glass as item 9.5. Cost Band 1– £0.00-£1,999.

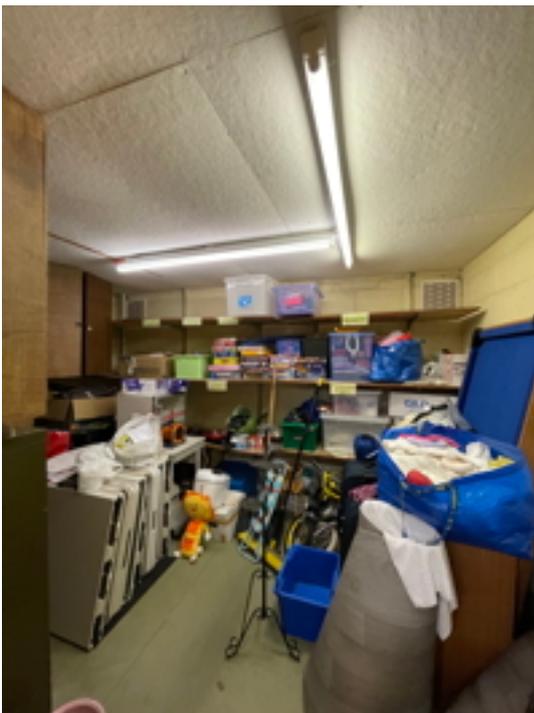
Hall Area Store

Satisfactory for Stores generally. Some cracking to exposed blockwork.

Monitor cracking to blockwork and advise if any movement. Cost Band 1– £0.00-£1,999.

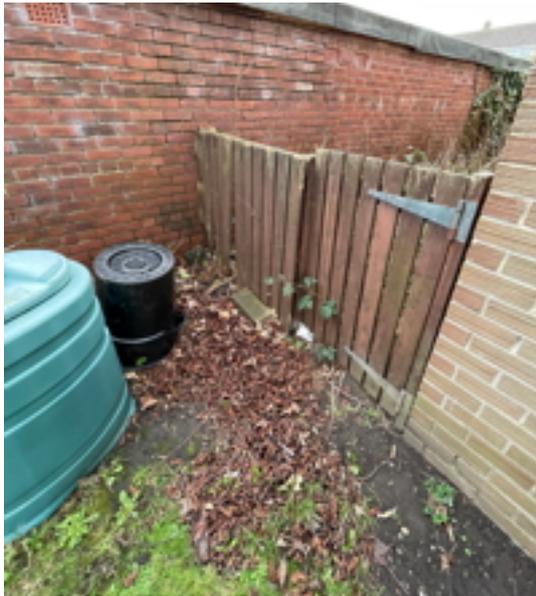
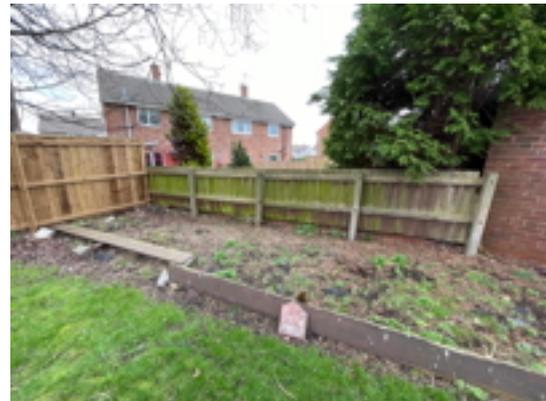
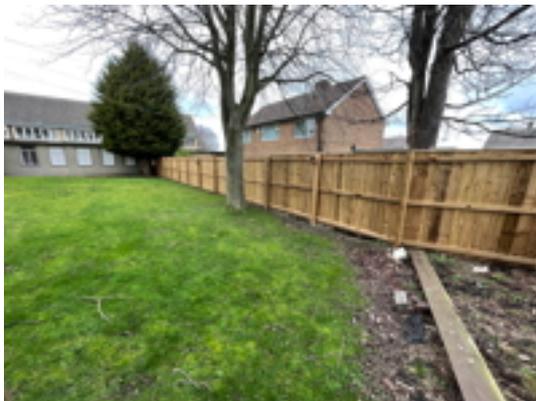
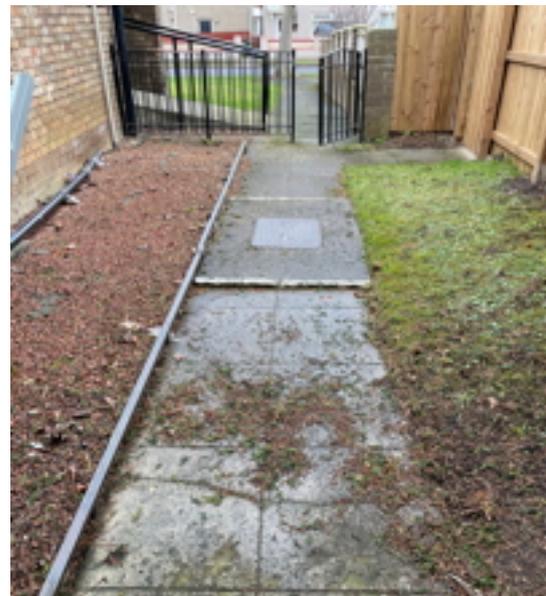
Fencing south boundary

Fencing east boundary

All generally in satisfactory condition. Expect some areas of rotten fencing to Courtyard Garden south end.

Repair rotten fence sections. Cost Band 1– £0.00-£1,999.

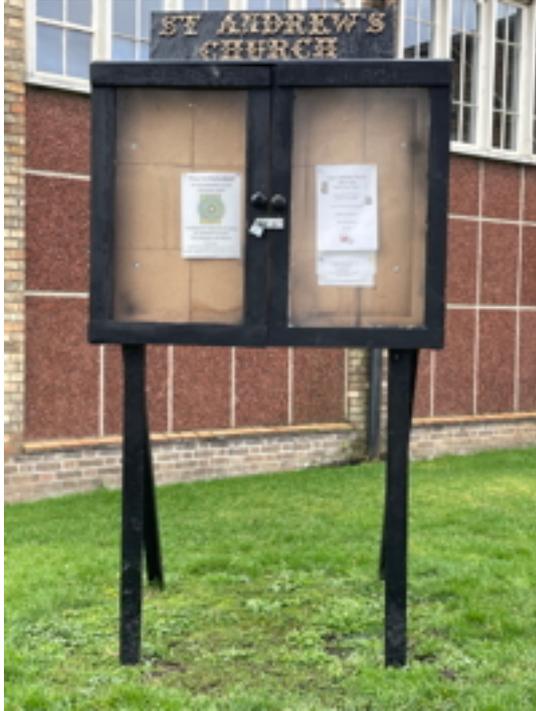
The Noticeboard is in satisfactory condition but currently contains very little information.

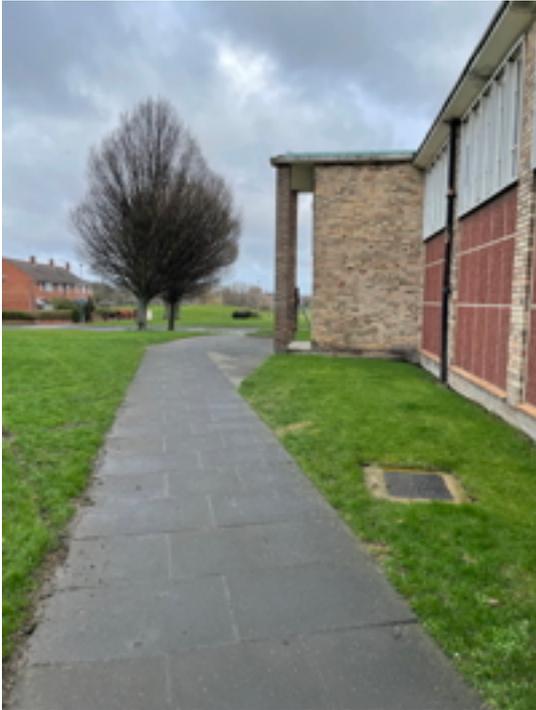
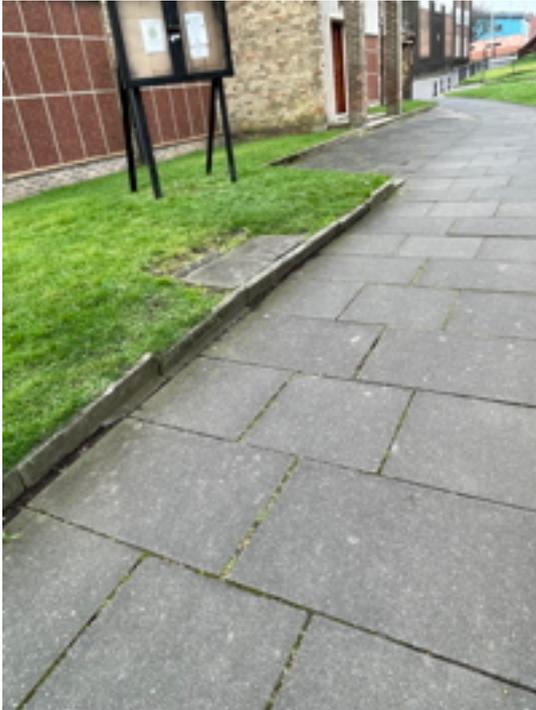
Northern pathway looking east

Northern pathway looking west

All is generally in satisfactory condition. Some uneven flags to north elevation pathway and some edge kerbs leaning. Some leaves and moss to courtyard paving. Missing paving flag to Hall entrance pathway steps.

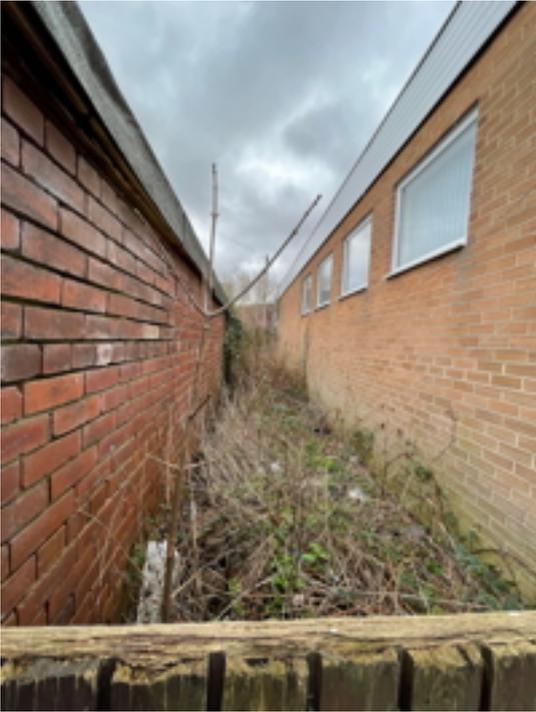
Hall south elevation overgrown

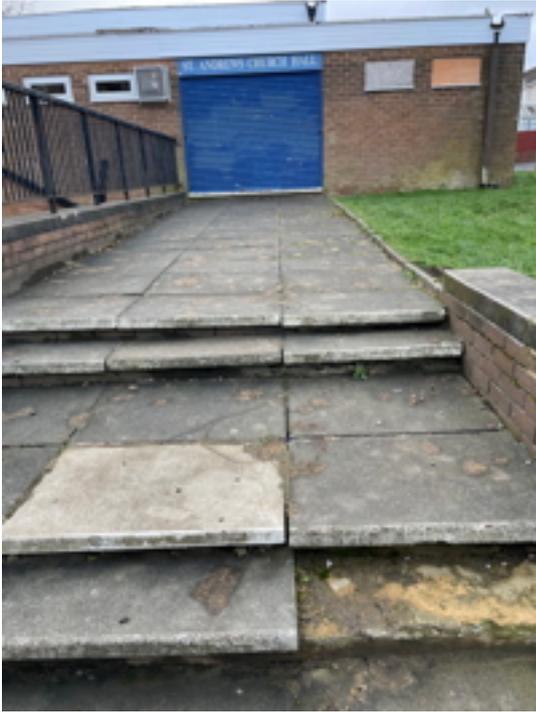
Main hall entrance path and steps

Replace missing flag to Hall Entrance pathway steps. Cost Band 1– £0.00-£1,999.

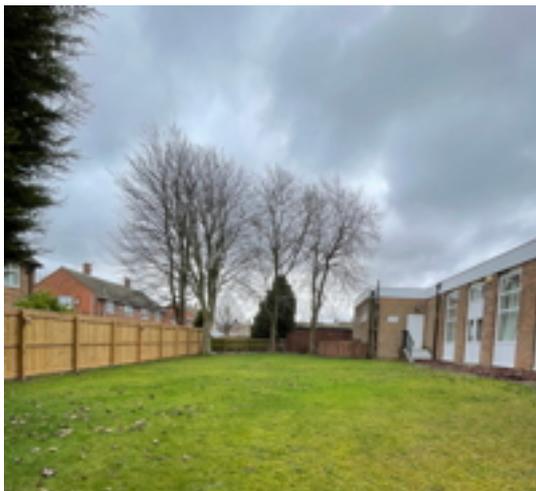
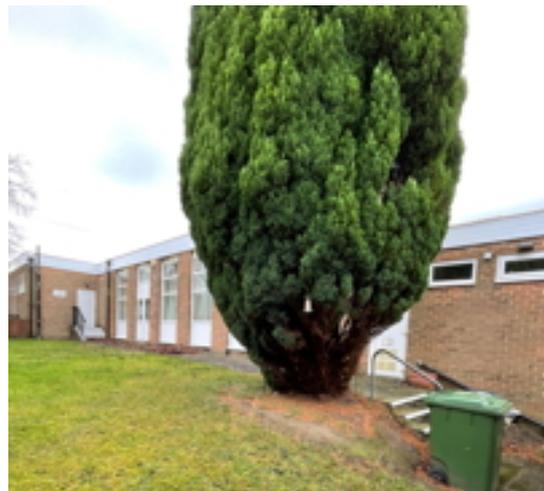
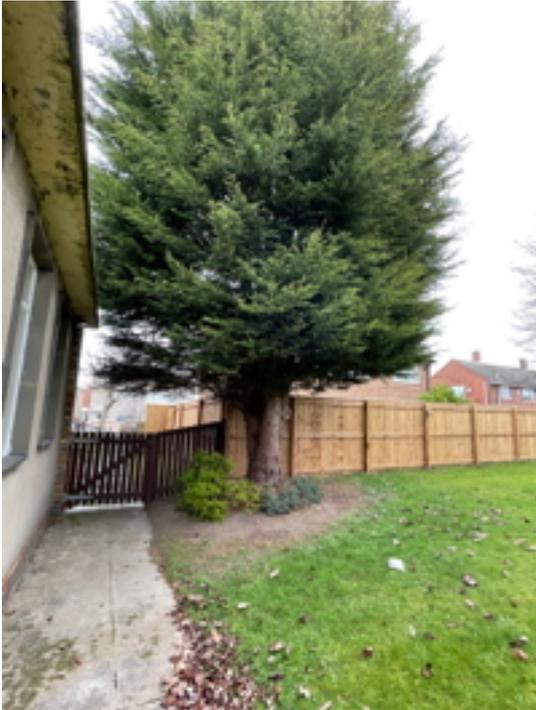
Deciduous trees to south boundary

Conifer to courtyard garden north west corner.

Conifer to courtyard garden north east corner.

The trees generally all appear to be in satisfactory condition. The trees should all be inspected by a qualified tree surgeon every five years, and pruned in accordance with their recommendations. The trees along the south side of the church are getting rather large and almost touching the church in places.

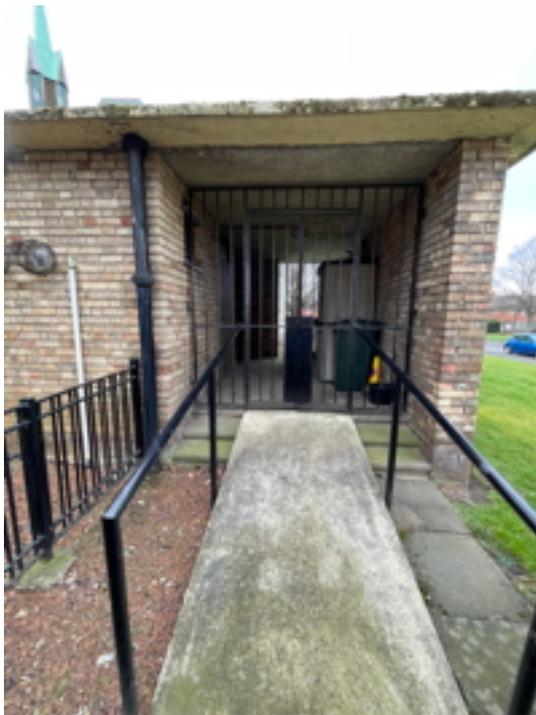
East Open Porch level access

All appears to be satisfactory except for the lack of wheelchair access and accessible WCs. It is noted that Open Porch is locked during services for security reasons and therefore that there is no alternative means of escape with level access if the Open Porch is not available. The ramp provided is relatively steep and does not provide Inclusive access. It is noted that the paving around the north porch could easily be raised to give Inclusive Level Access to the main entrance to the Church.
