Care of Churches and Ecclesiastical Jurisdiction Measure 1991 – Quinquennial Inspection
ALL SAINTS, EAGLESCLIFFE

Diocese: Durham
Archdeaconry: Auckland
Church Code: 613 312

Date of Inspection: 23rd June 2022
Inspection undertaken by: Jamie Holden BA (Hons) RIBA RIAS
Previously Inspection: Nov 2014 by D Beaumont

Studio Tamacoco Architects

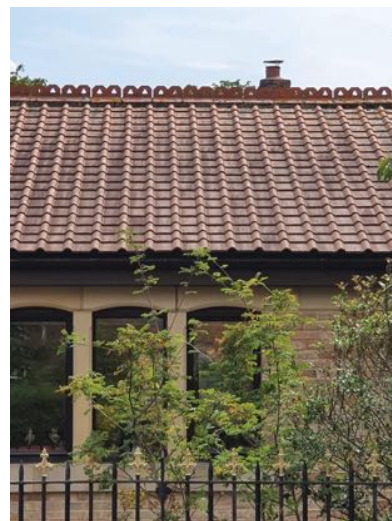
b) Single roll clay tiles with decorative ridges.

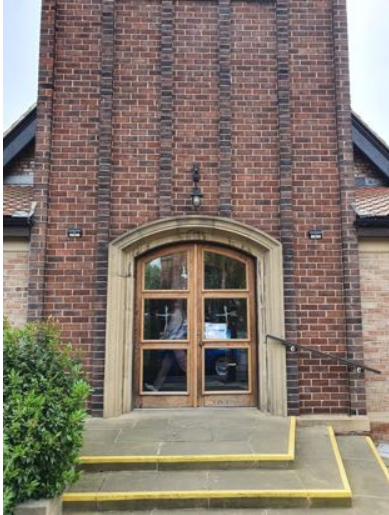
- 3.1.3 It is understood the entrance doors in the west elevation were installed in 2018. They stick slightly when opened. Relatively new oak such as this can be sensitive to moisture so might swell a little during the damp winter months and be even more prone to sticking. An experienced joiner should be invited to adjust the doors in order that they are as easily operated as possible. This will ensure good accessibility and help avoid any damage that might be caused if they stick and need to be forced on a regular basis. **2**

a) Oak doors to be adjusted to easy opening.

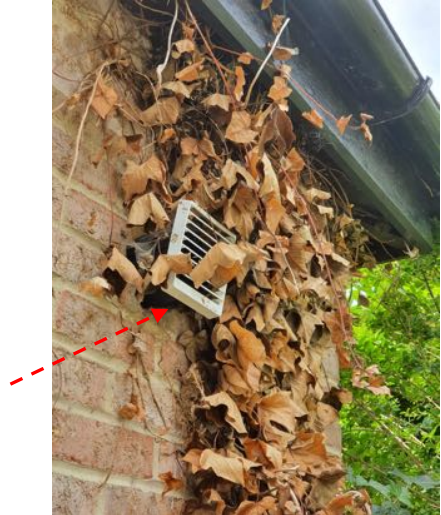
- 3.8.5 A vent extract has not been properly cut back and its terminal is not secured to the brickwork. Properly secure the extract vent and remove ivy. **2**

b) Secure extract vent terminal.

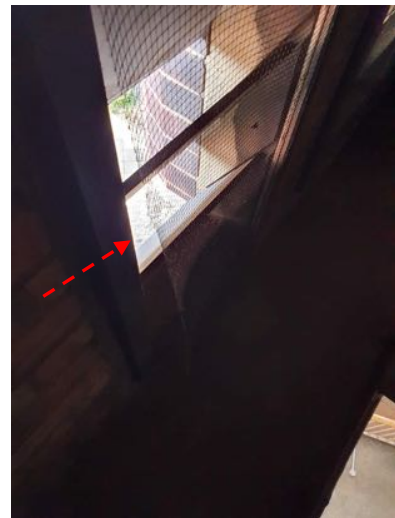
- 4.5.2 The structural openings are all well protected with bird mesh and the interior is very clean as a result. However, the mesh has work loose in one instance and should be re-fixed. **2**

b) Bird mesh to be re-fixed.

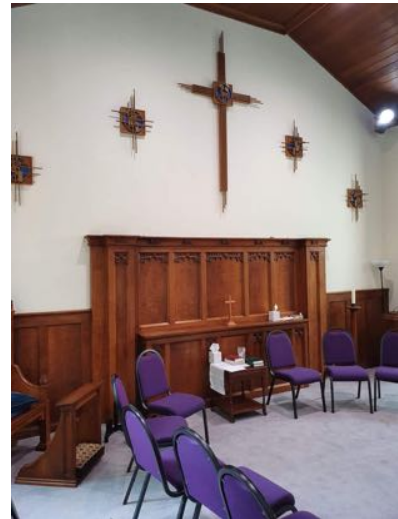
b) East wall with reredos and crucifix.

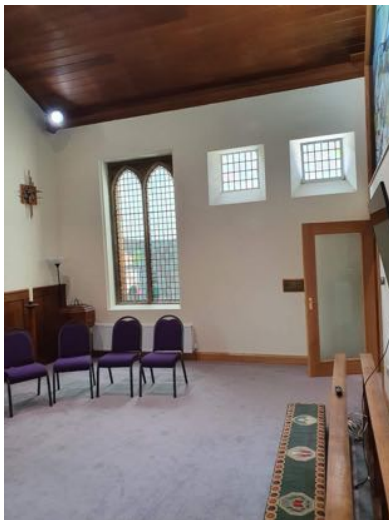
a) South wall

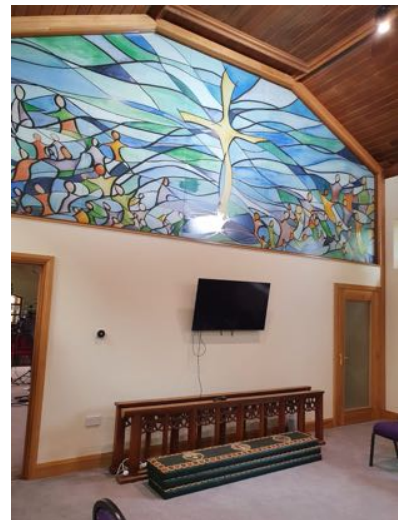
b) Partition with decorative glazing.

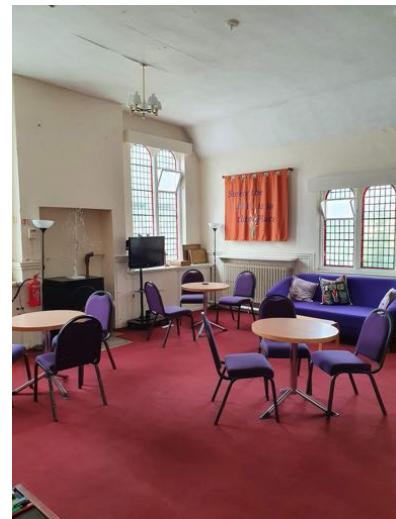
b) Looking towards the SW corner

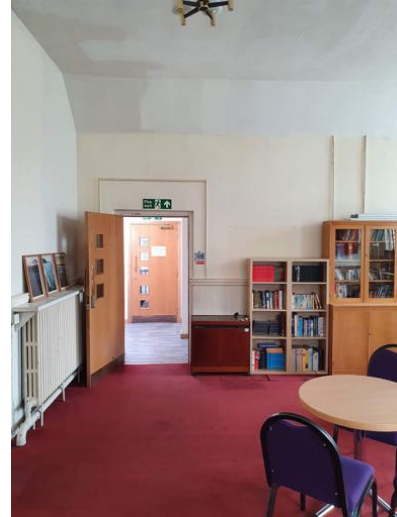
b) Access to the Community Hall

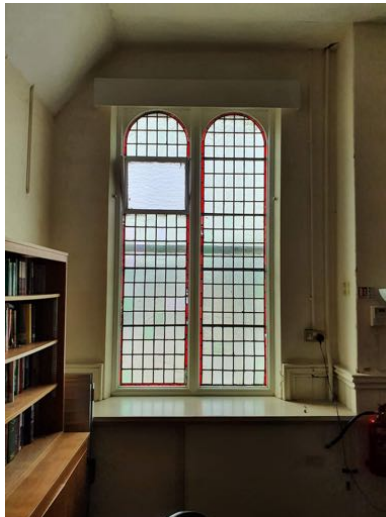
- 4.10.3 There are two tall timber framed windows in the south wall with a central mullion forming two light with rounded heads. Each light has clear rectangular leaded glass with a red boarder. There is one window in the west elevation with the same detail but shorter in height. The leaded panels are secured to saddle bars but have buckled significantly and numerous panes are cracked. The glazing is protected by the external secondary glazing system but ought to be repaired by a suitable specialist in due course. **5**

a) South window

To the Library the leaded windows need a thorough overhaul, repointing is required to the brickwork and the interior plaster finishes are in need of repair. There is justification for doing this work now but it is understood the plans to reorder the Library are under consideration. Therefore, it is reasonable to pause commencement on these repairs in order to establish if they can be incorporated and complement any alterations that might take place in the near future.

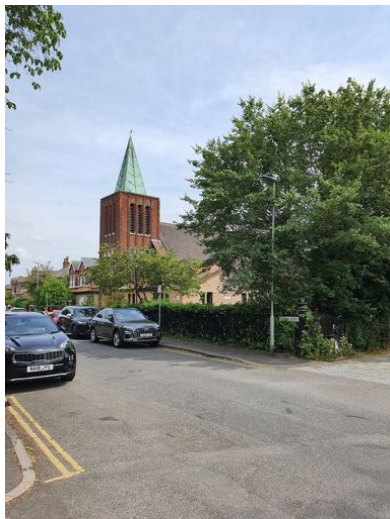
a) View of the east boundary on Dunottar Avenue

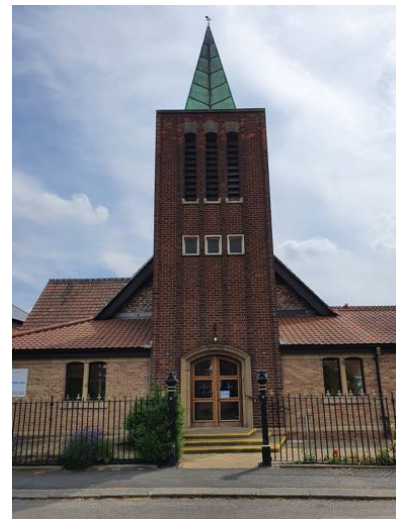
b) Gateposts and railings at the main entrance

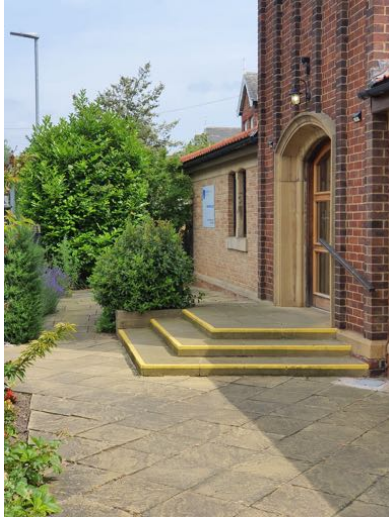
a) Steps and ramp to main entrance

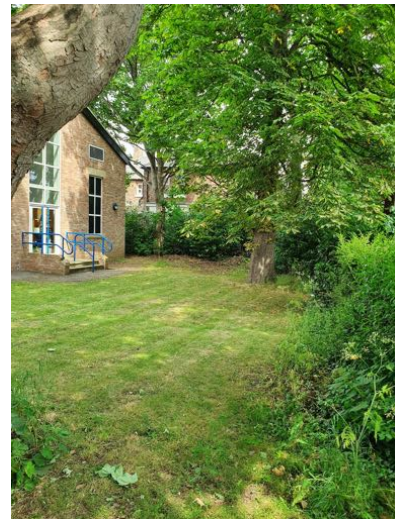
b) East side of the churchyard.

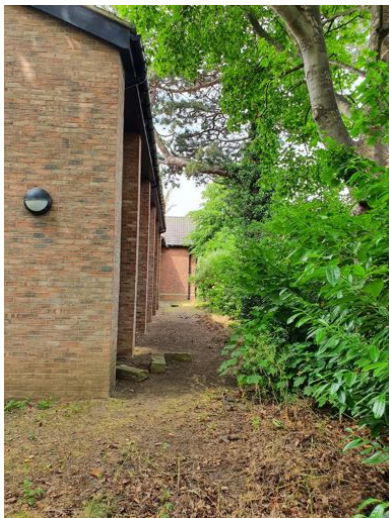
a) The north boundary is heavily planted with shrubs and mature trees

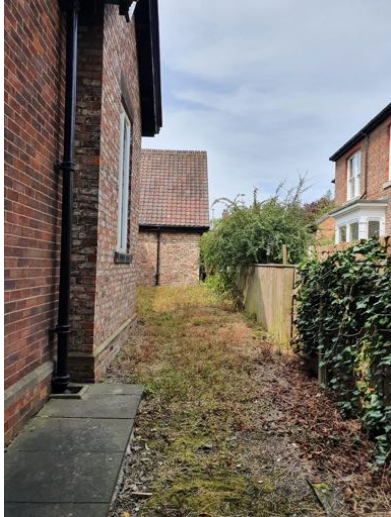
- 5.1.7 There is a narrow strip of land to the north of the building. This has been rather unkempt in the past but has recently been cleared as the PCC consider how the space could be managed as a wildflower area creating more habitat diversity. This approach is encouraged.

a) This area to the north of the Church is being consider as a wildflower habitat.

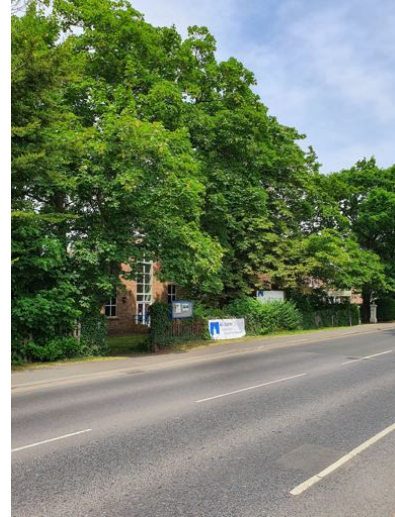
b) West boundary on Yarm Rd.
