**Quinquennial Inspection Report
The Church of St Stephen's, South Shields
Archdeaconry of Sunderland
Deanery of Jarrow
Diocese of Durham**

David Jowett - Architect, BA, DipArch, RIBA
25 Roseworth Avenue
Gosforth
Newcastle upon Tyne
NE3 1NB
Tel: 07788 710 204
email: david@davidjowett-architect.co.uk

18 December 2024

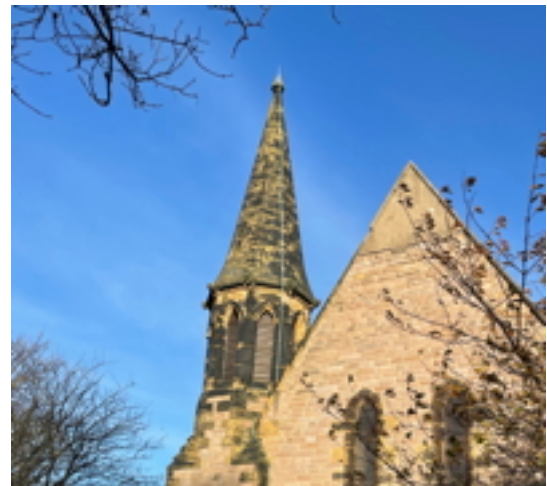
West Elevation Gable and Spirelet

Missing lead flashing to south porch east and west elevations. Misaligned coping and leadwork to nave south elevation east end. A vestry chimney has been reduced to a stepped return parapet in stone and brick with concrete tables. West end north gable coping stone displaced near peak.

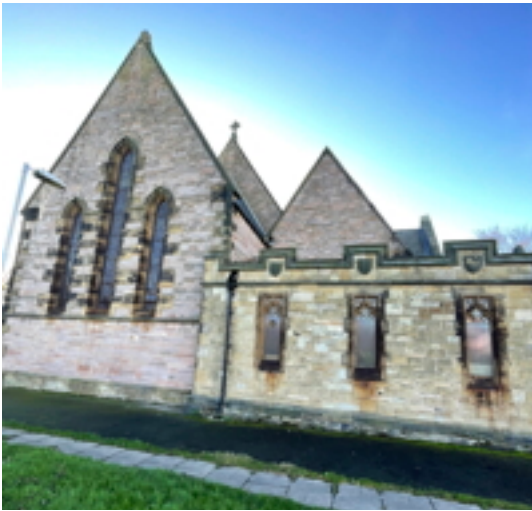
The pink sandstone is generally eroding due to the severe exposure of the site, especially near the tops of the gables where stones are so deeply weathered that they are rounded like river stones. The yellow sandstone including the quoins and other dressings are tougher.

Contrasting Pink and Yellow Sandstone

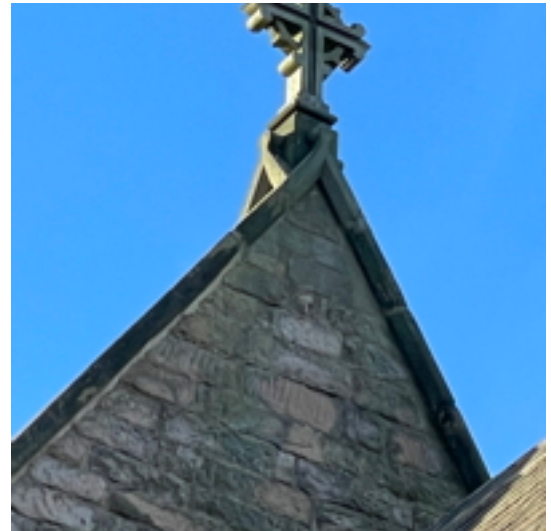
Nave east wall just below the peak appears to have some open joints.

Open Joint Nave East Gable

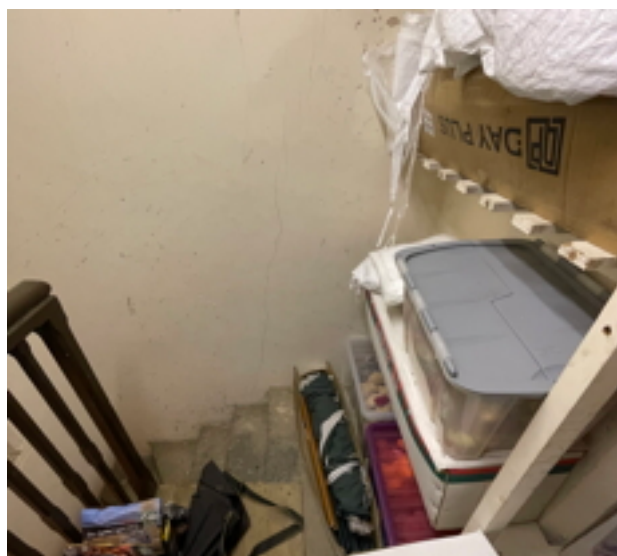
Clutter within Tower

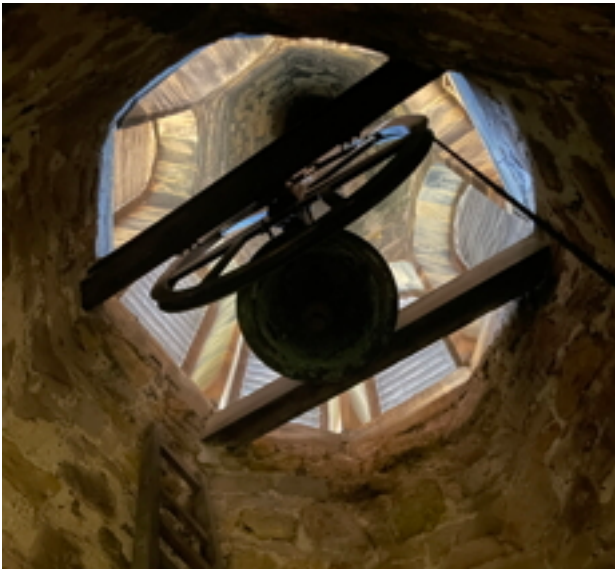
The bell was reported to be in working order.

Agree a maintenance schedule based on usage with a bell maintenance company. Cost Band 1-£0.00-£1,999

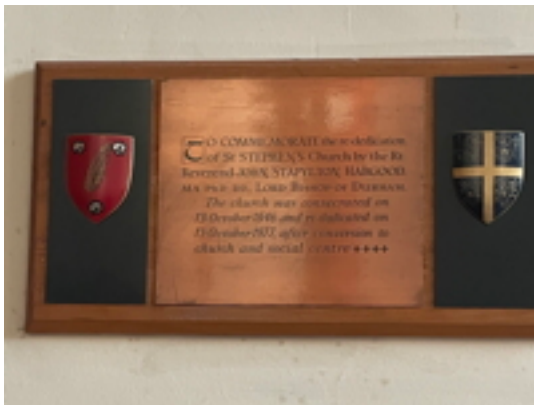
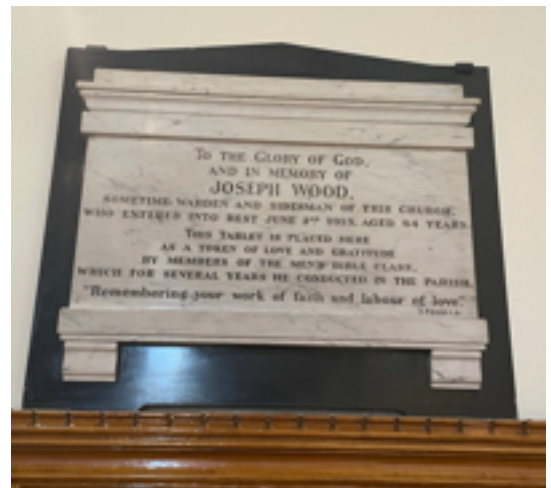
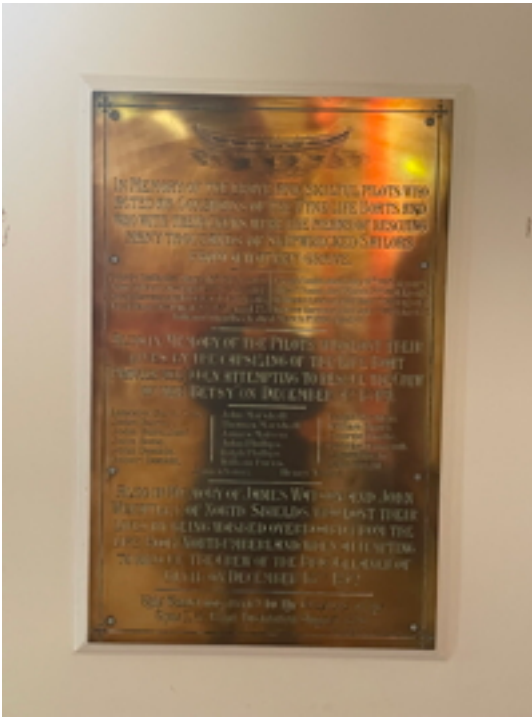
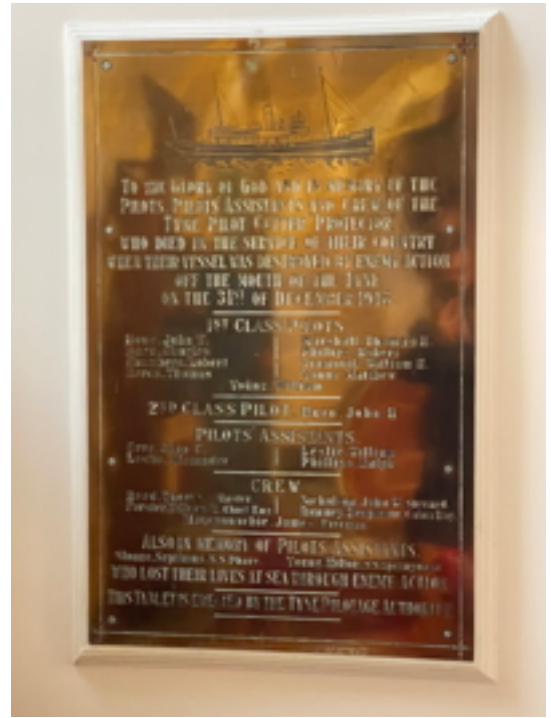
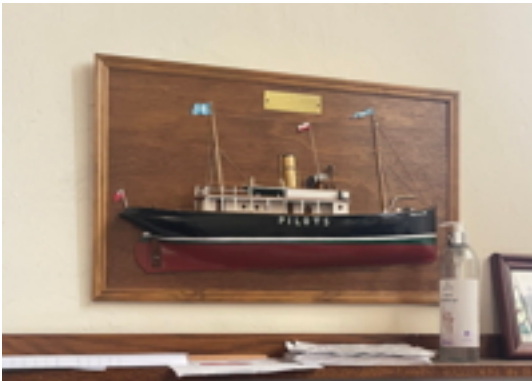
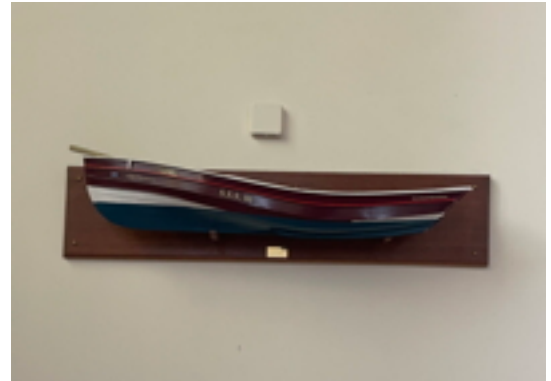
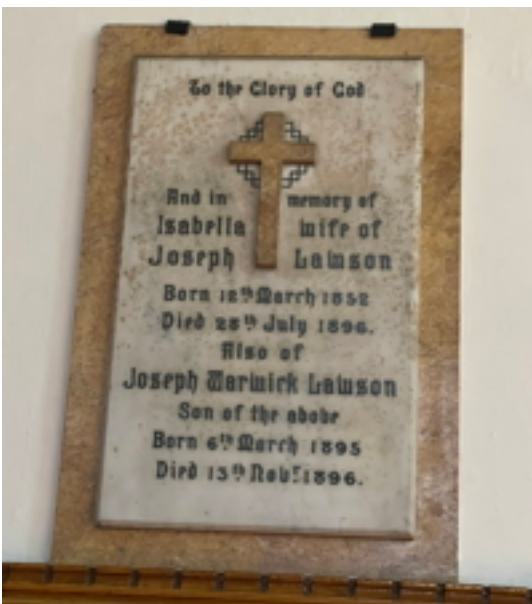
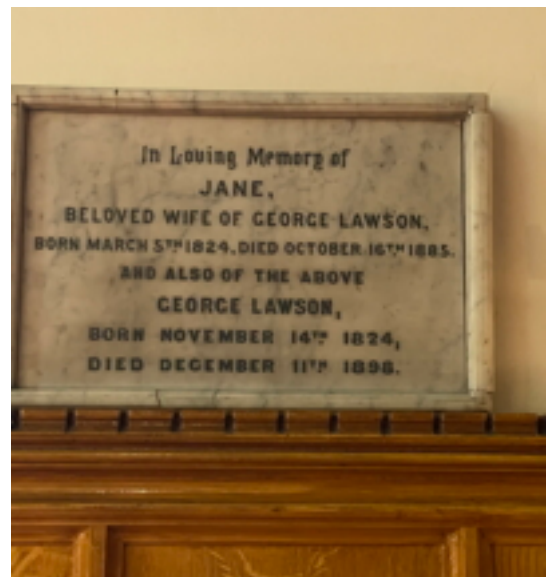
All memorials are in good condition and well cared for.

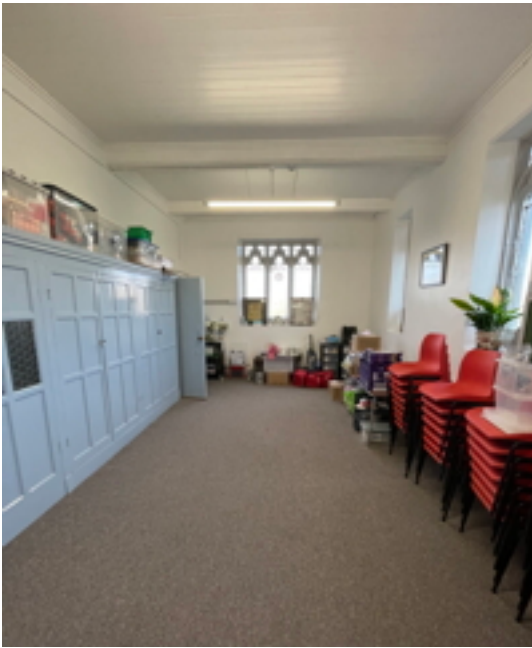
Choir Vestry/Meeting Room Looking North

The Choir Vestry/Meeting Room is all in fair condition.

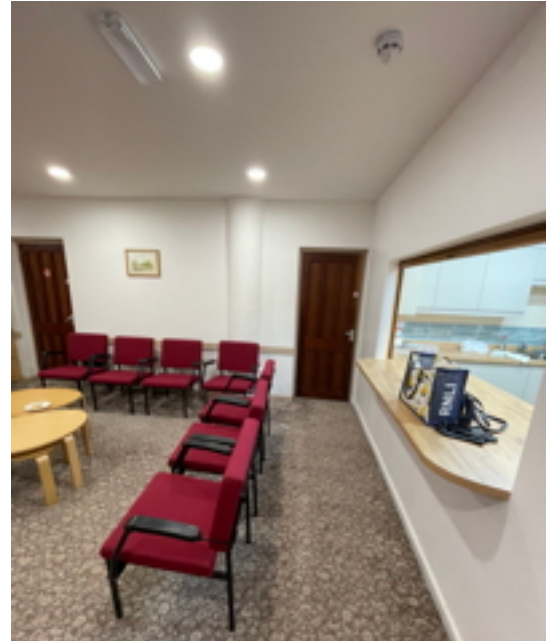
Lounge Looking East

The lounge is all in good condition.

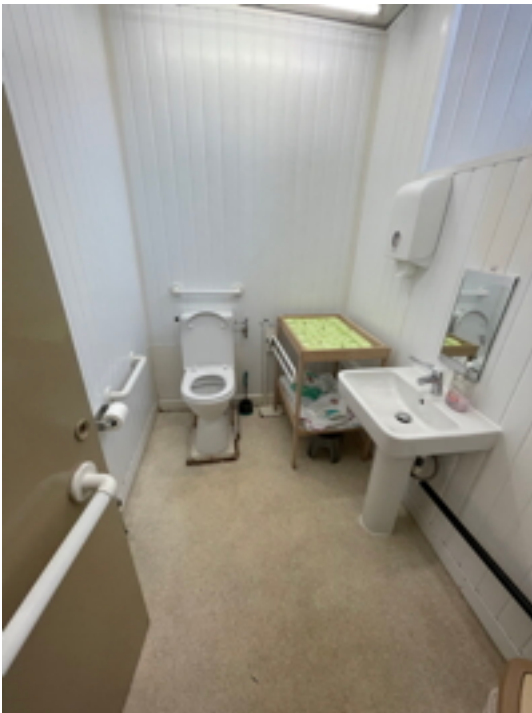
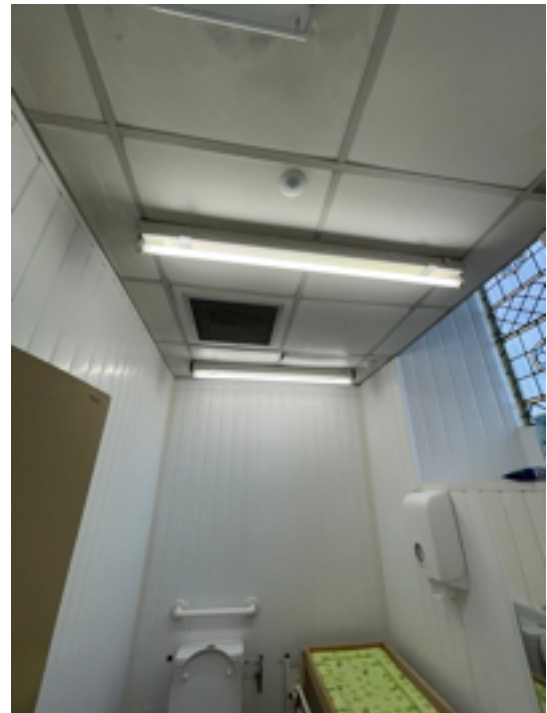
WC Looking West

The WC has vinyl on a suspended floor. The walls are panelling. The ceiling is suspended ceiling tiles. Door is flush painted timber. The WC is wheelchair accessible and has the full current equipment except it lacks the recommended audible and visible alarm.

The WC is all in reasonable condition.

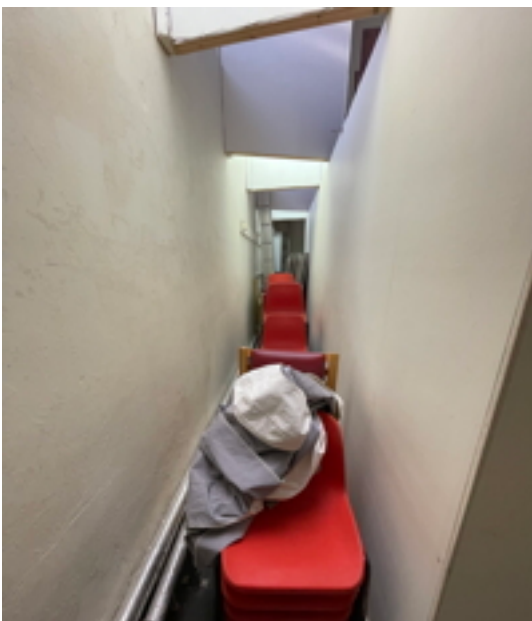
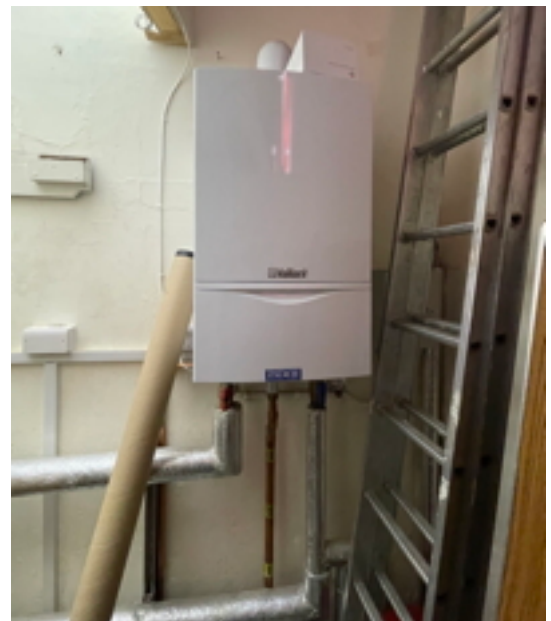
West End Store Looking North

Condition is generally fair.

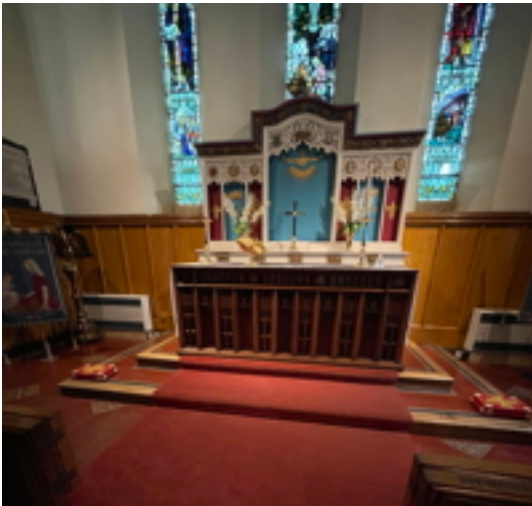
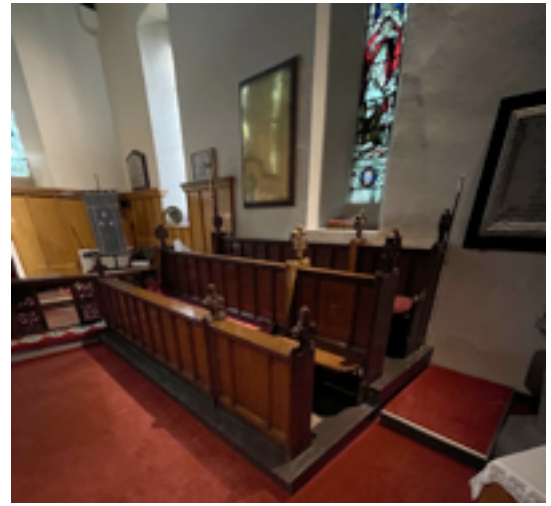
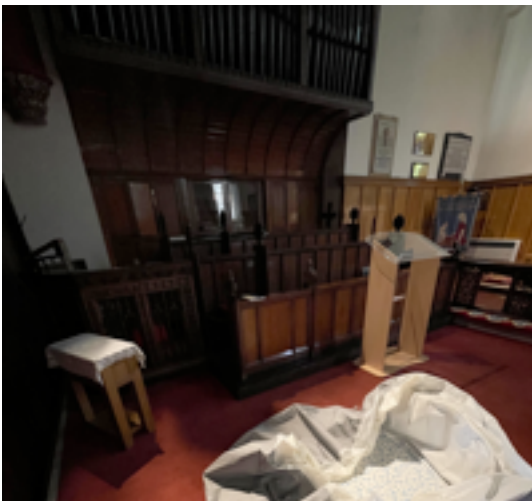
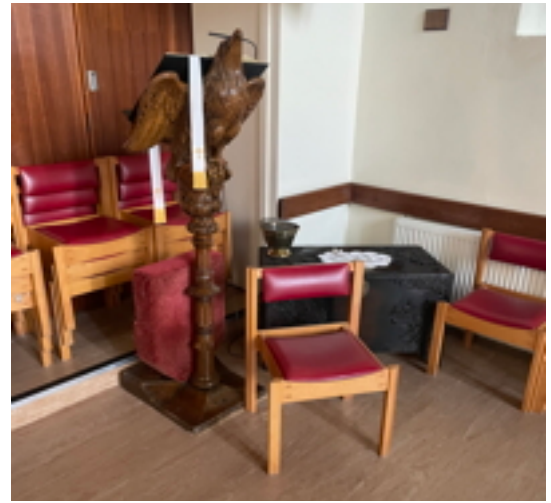
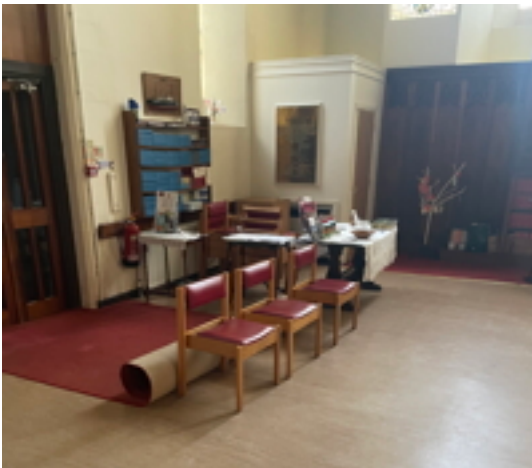
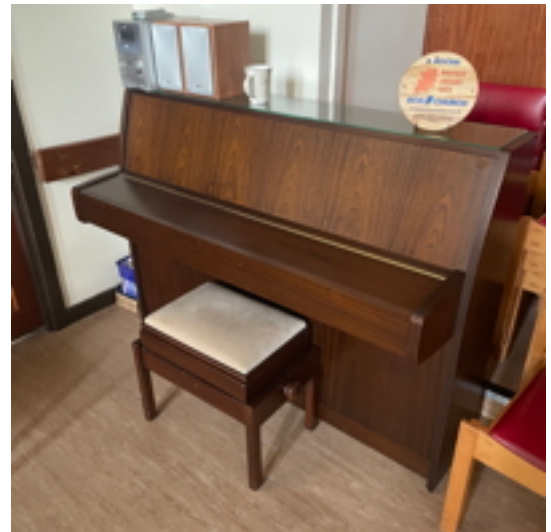
All are in satisfactory condition.

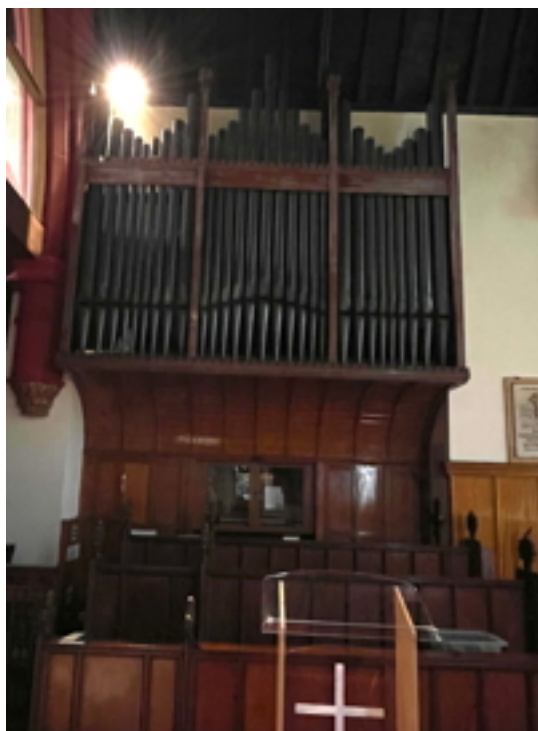
Organ Chancel North Side

The Organ Tuner's Book is stored beside organ and the most recent entry is 8 August 2023.

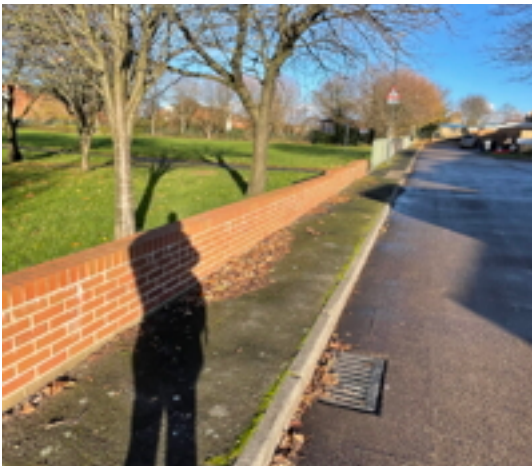
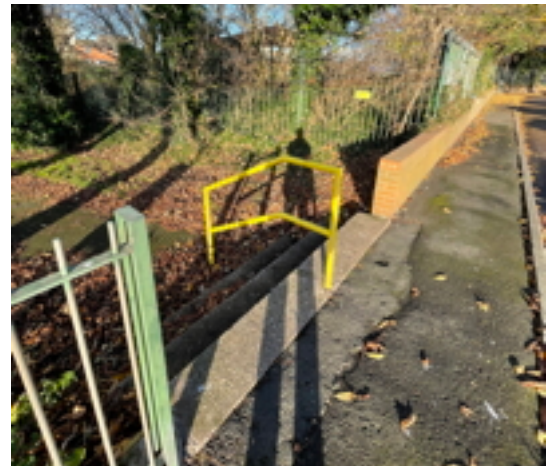
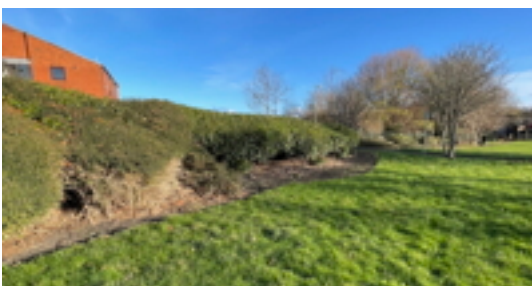
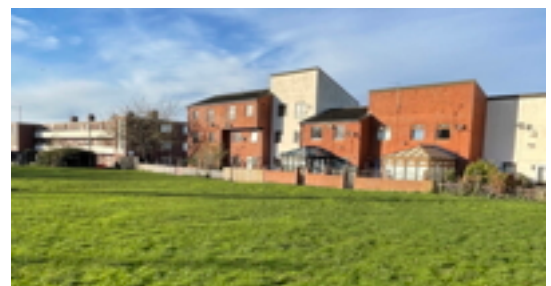
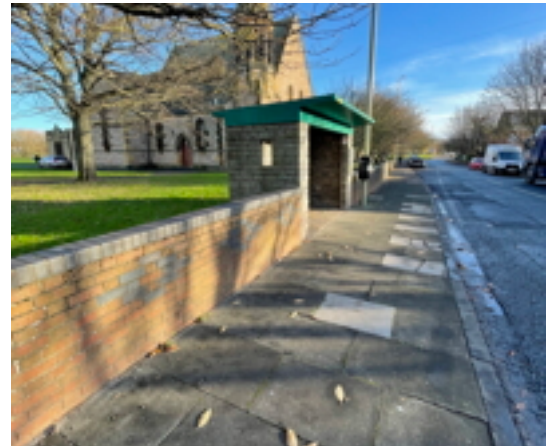
All is in satisfactory condition.

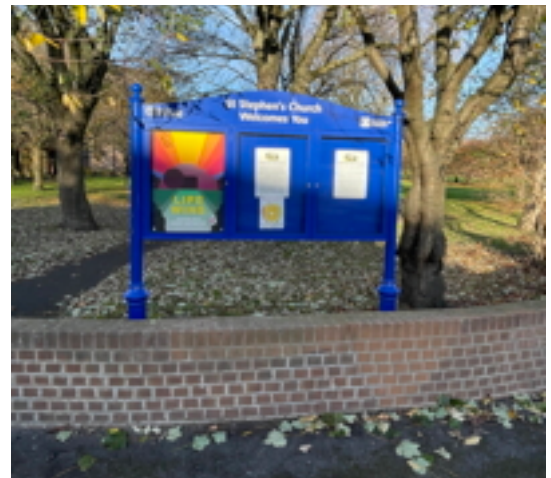
Noticeboard

The noticeboard is in good condition.

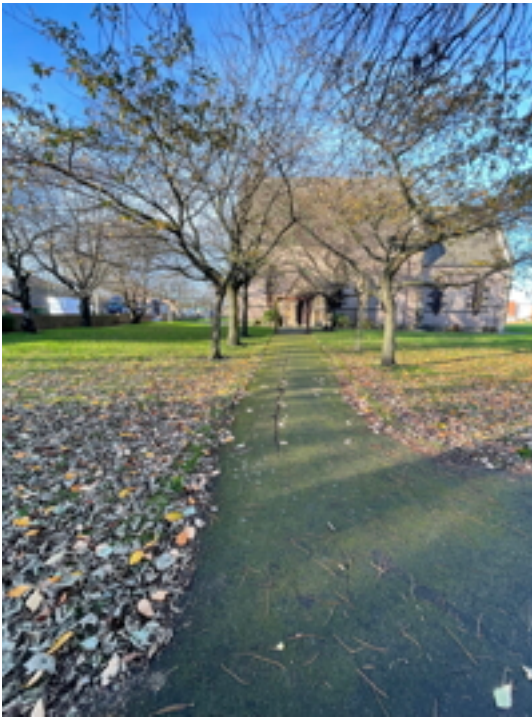
Looking North

All is in satisfactory condition.

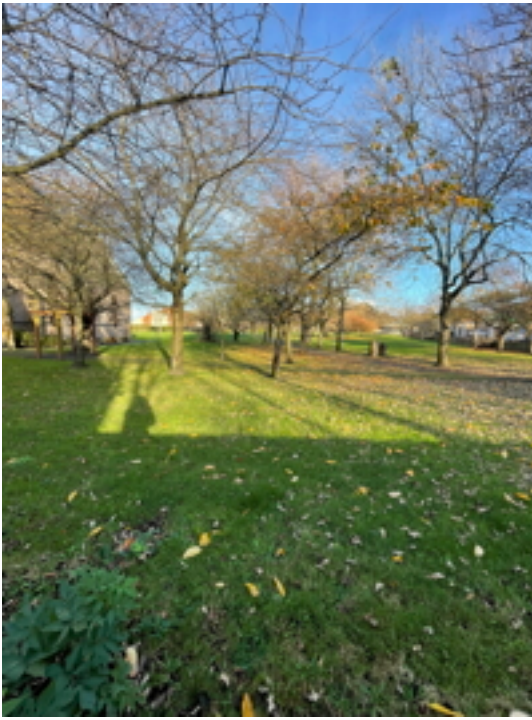
Trees to South West

All in satisfactory condition .
