Care of Churches and Ecclesiastical Jurisdiction Measure 1991 – Quinquennial Inspection  
**ST CHADS, SUNDERLAND**

Diocese: Durham  
Archdeaconry: Sunderland  
Church Code: 613 181

Date of Inspection: 05<sup>th</sup> May 2022  
Inspection undertaken by: Jamie Holden BA (Hons) RIBA RIAS  
Previously Inspection: July 2015 by Lucy Stewart

**Studio Tamacoco Architects**

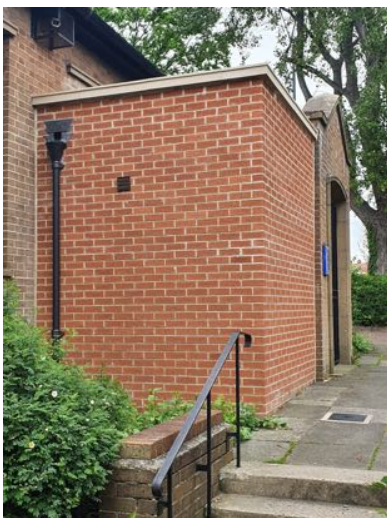
*a) The porch was extended in 2020*

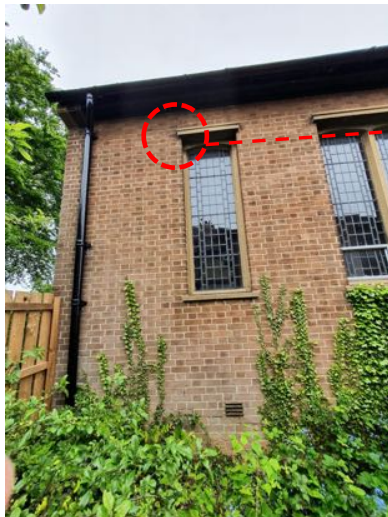
- 3.4.3 There are cracked joints at the head of the first window from the west. The internal plaster finish is also cracked in the corresponding location. This suggests structural movement/ settlement which is likely to have occurred many years ago and might now be static. There are similar cracks to some of the other windows that appear to have been repointed previously.

a) First window from the west.

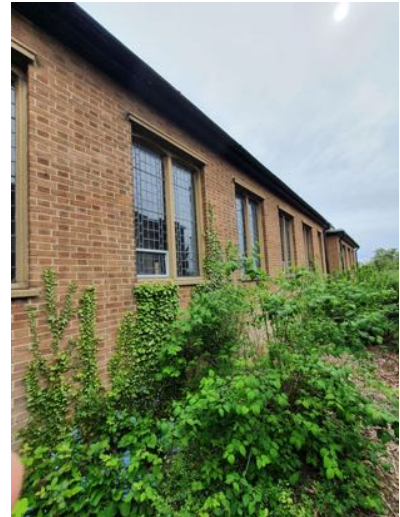
b) View looking east. Access is restricted.

- 3.4.6 Once the vegetation has been cleared and the area south of the Church is accessible **2** the south side of the building should be given a fully inspection and the findings appended to this report.

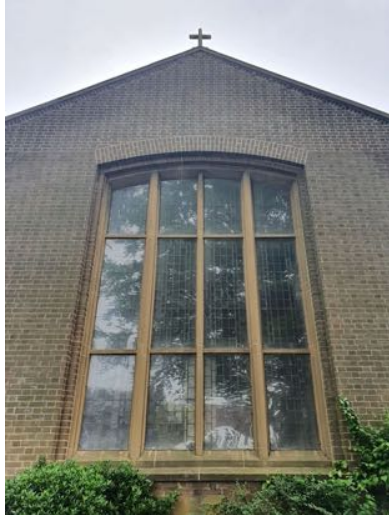
3.5.9

a) West window

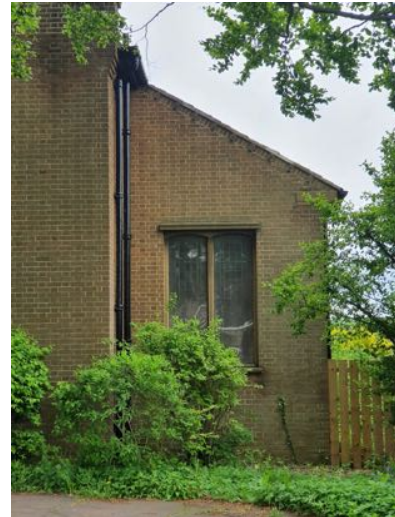
b) North Aisle window to be repaired.

b) West window of North Aisle

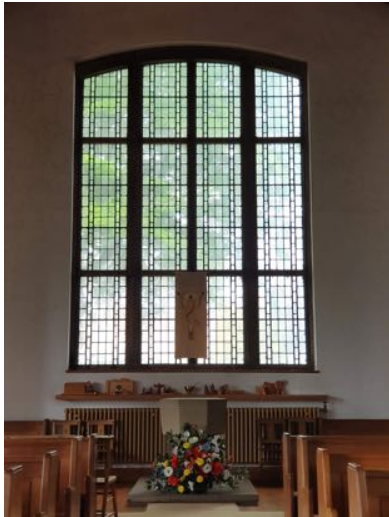
4.3.11

a) West window

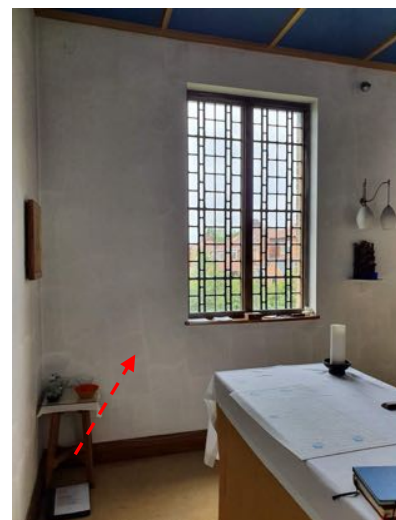
b) South wall shows a similar crazed pattern in the plasterwork.

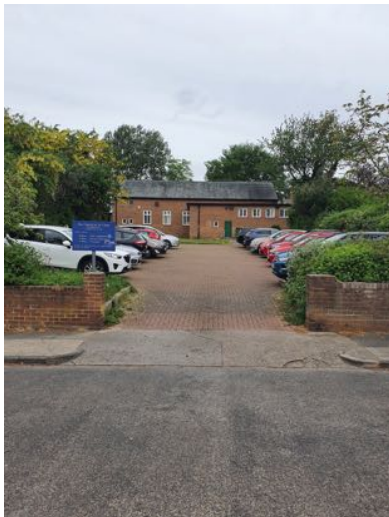
*a) Vehicle access from the east*

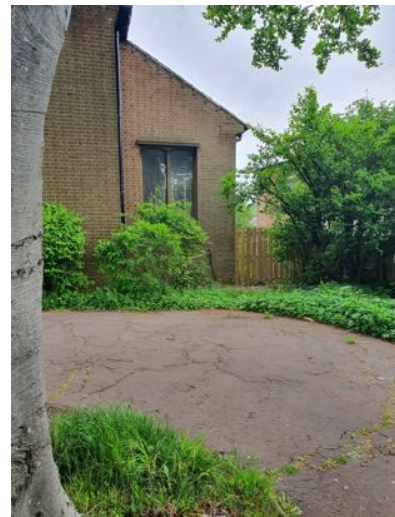
*b) South side of church fenced off without access.*
